Fatigue of Ti-6Al-4V thin parts made by electron beam melting

THESE de DOCTORAT DE L'UNIVERSITE DE LYON
opérée au sein de
L'Institut National des Sciences Appliquées de Lyon

**Fatigue of Ti-6Al-4V thin parts made by
Electron Beam Melting**

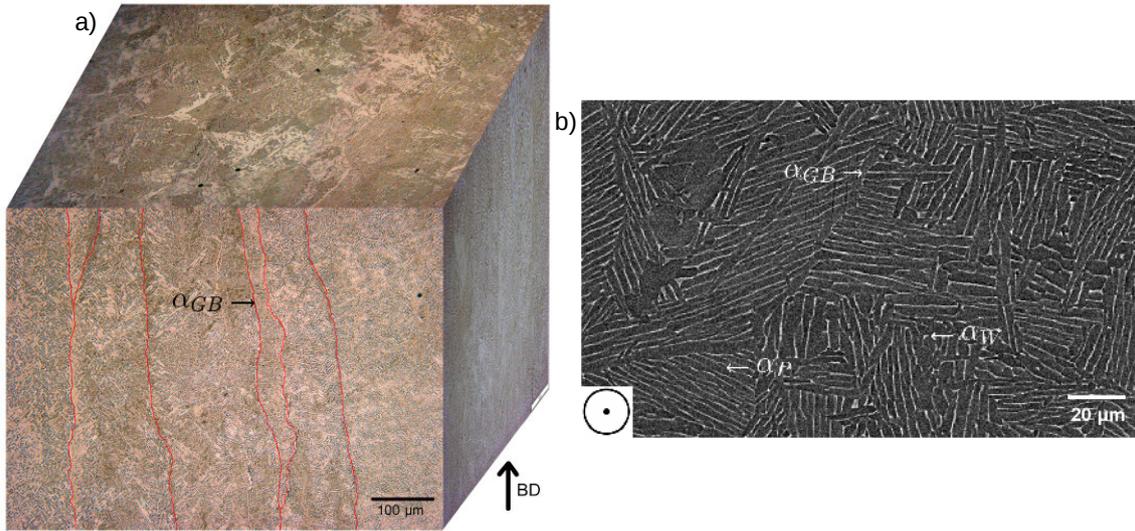
Figure 1.3: (a) 3D optical micrographs from a Ti-6Al-4V sample manufactured by EBM. The boundaries of the prior β grains are highlighted in red. (b) SEM-BSE micrograph of a plane perpendicular to the build direction at a higher magnification. α_{GB} , α_P and α_W respectively indicate the α phase that nucleated at the prior β grain boundaries, the α laths grown from the grain boundaries and new α laths nucleated at the interface of the α_P . Adapted from [SUA 15b].

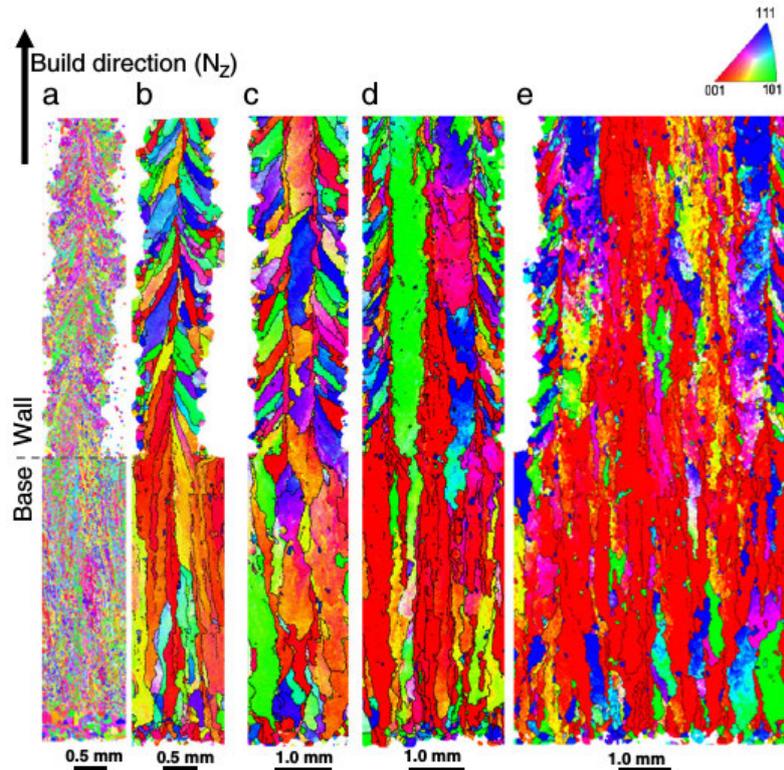
Figure 1.4: EBSD maps from XZ cross sections of vertical walls built on a continuous base. (a) Example of an original α phase map. (b-e) Examples of the reconstructed prior β grains for respectively 1 mm (b), 1.5 mm (c), 2.0 mm (d), and 5 mm wide walls (e). The black lines delineate boundaries (misorientation $> 15^\circ$). The IPF orientation contrast is with respect to the build direction NZ. Adapted from [ANT 13].

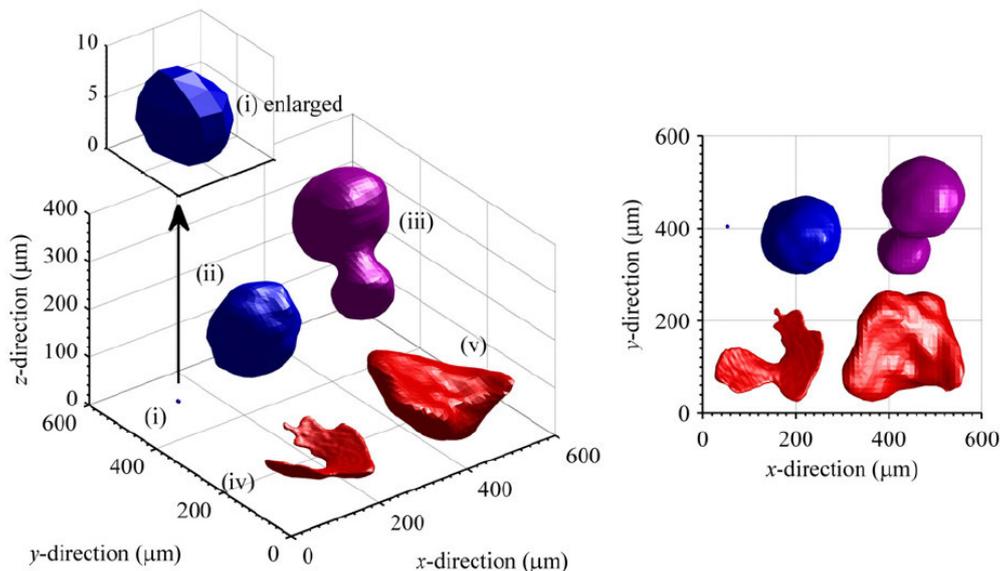
Figure 1.5: Examples of pore types observed in EBM samples: small (i) and large (ii) *gas pores* (blue), (iii) two *gas pores* joined together (turquoise) and small (iv) and large (v) *lack-of-fusion defects* (red). The build direction is shown by an arrow. An enlarged view of (i) is provided in the inset. Low and high resolution X-ray tomographic scans (voxel size = 10 and 2 μm respectively) have been used to respectively detect large (ii, iii and v) and small defects (i, iv). Adapted from [TAM 15].

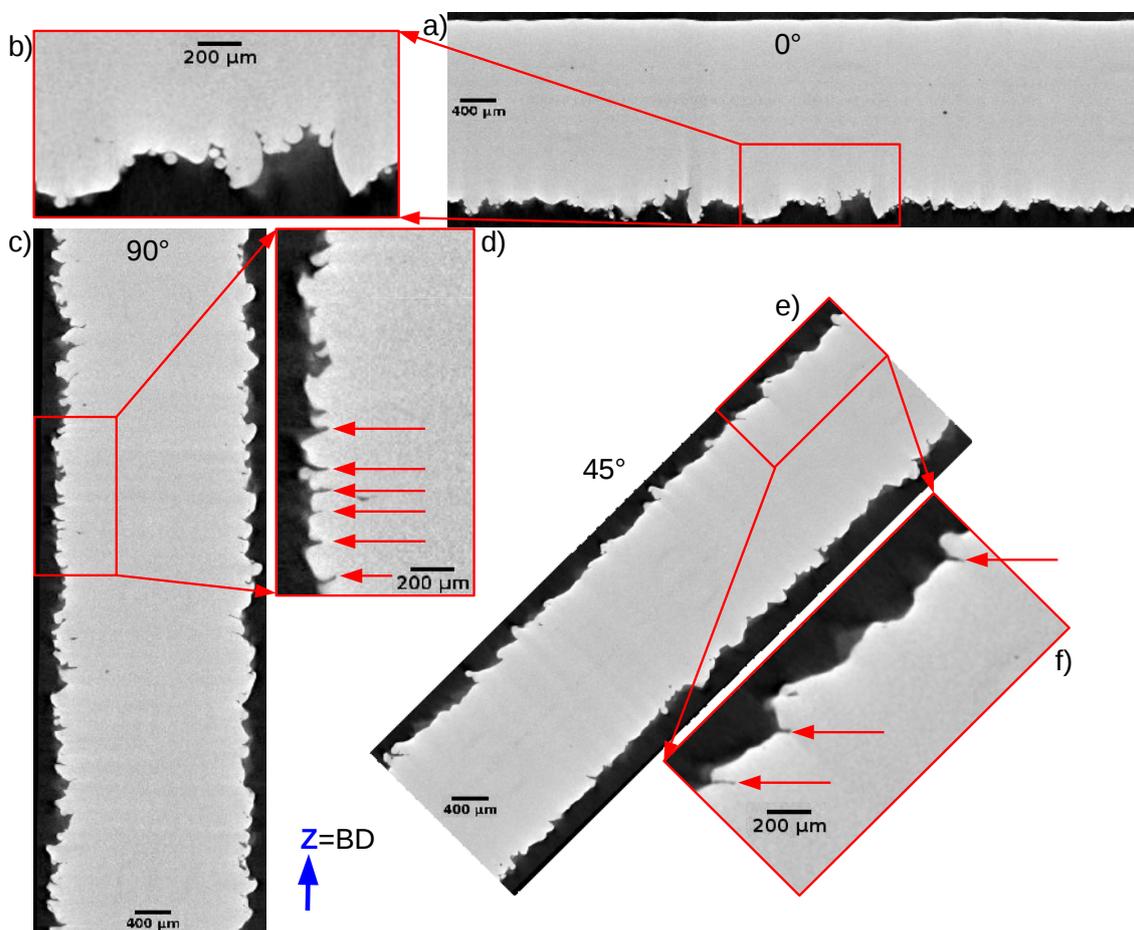
Figure 1.18: Impact of the build orientation on the surface of the samples gauge length. (a, c and e) Radial slices of samples manufactured respectively at 0° , 45° and 90° . (b, d and f) Magnification around surface defects. The slices are oriented in order to mimic the sample orientation in the build chamber, the building direction being vertical (blue arrow). Red arrows show notch-like defects.

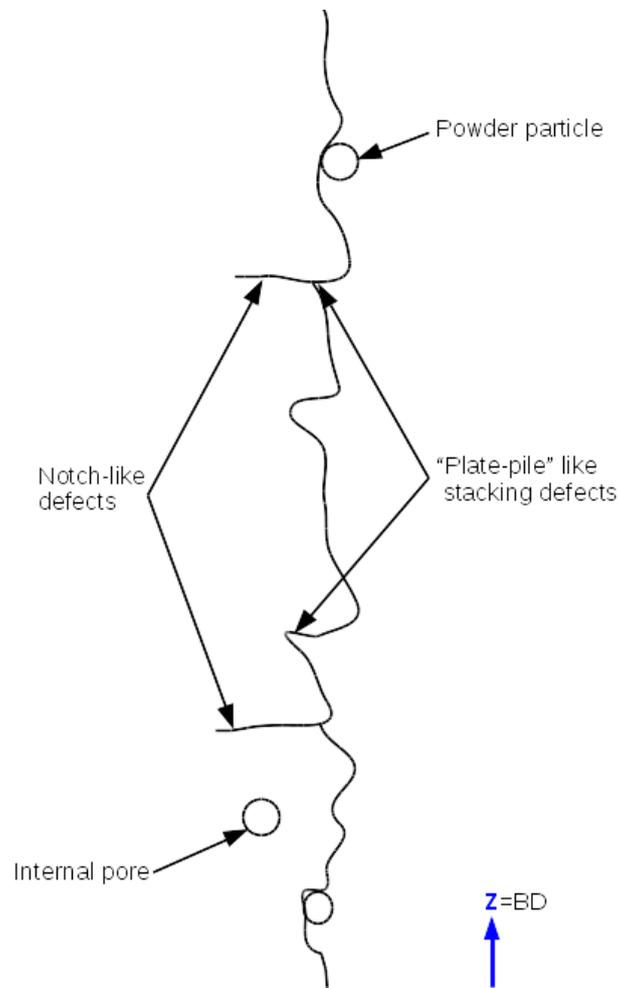
Figure 1.19: Schematic illustration of the defects that can be found in EBM as-built samples. The building direction is indicated by the blue arrow.

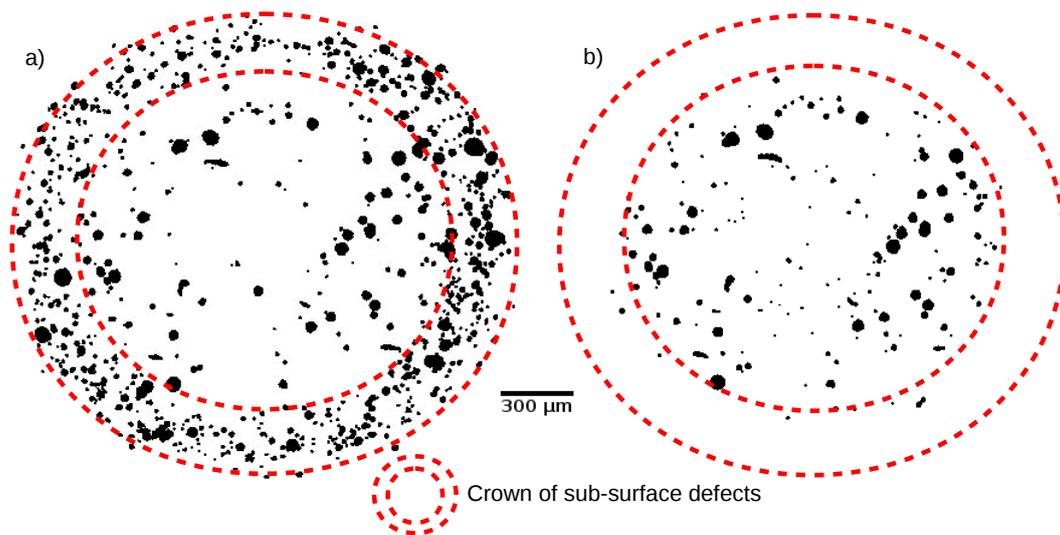
Figure 1.30: Projected views of all the internal pores within the gauge length of a 90° sample before (a) and after 30 min (b) of chemical etching. After 30 min of etching time, the sub-surface ring with a higher density of internal defects has been completely removed. The corresponding volume fraction pores are respectively 0.025% and 0.010%.

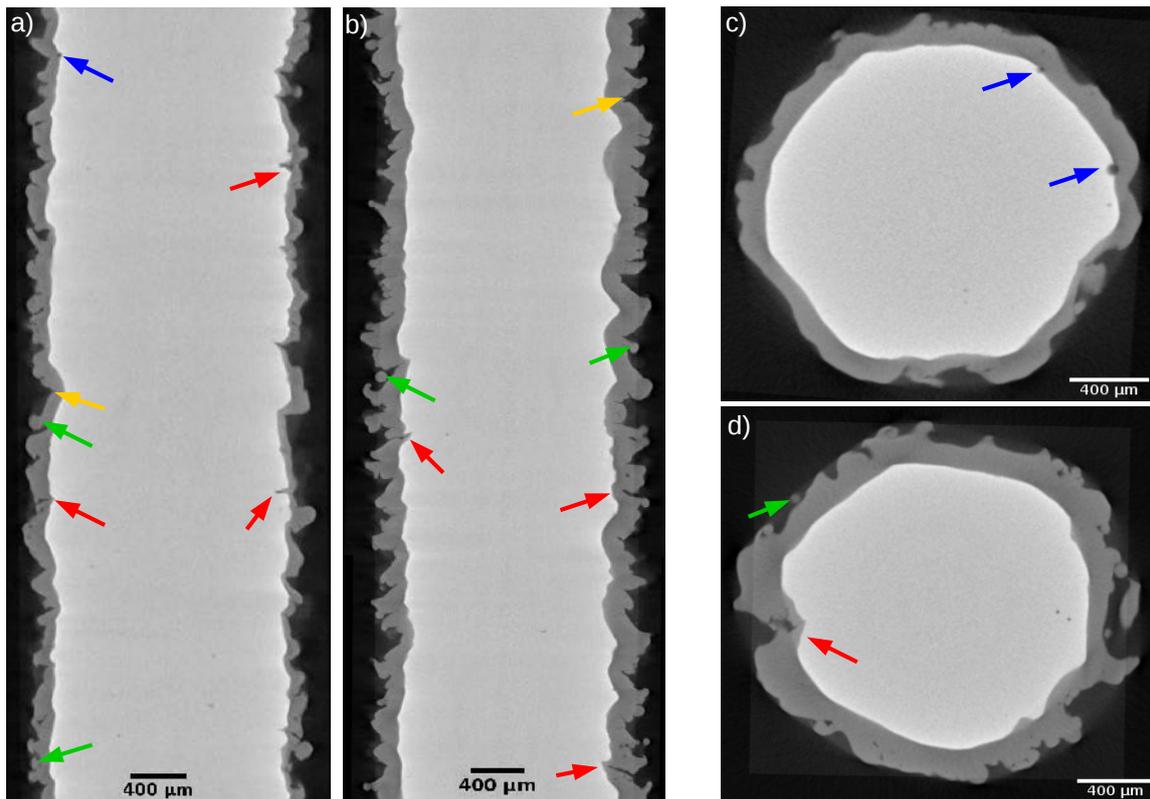
Figure 1.31: Effect of chemical etching on the surface of the gauge length of as-built specimens. Dark gray: sample cross section before etching; light gray: after etching. (a, b) Radial slices after respectively 30 min and 1 h of etching time. (c,d) Axial slices after respectively 30 min and 1 h of etching time. Green and orange arrows show respectively unmelted powder particules stuck to the surface and plate-pile like stacking defects, both in the as-built state. Red arrows point out notch-like defects. Blue arrows indicate sub-surface defects which became surface defects due to chemical etching.

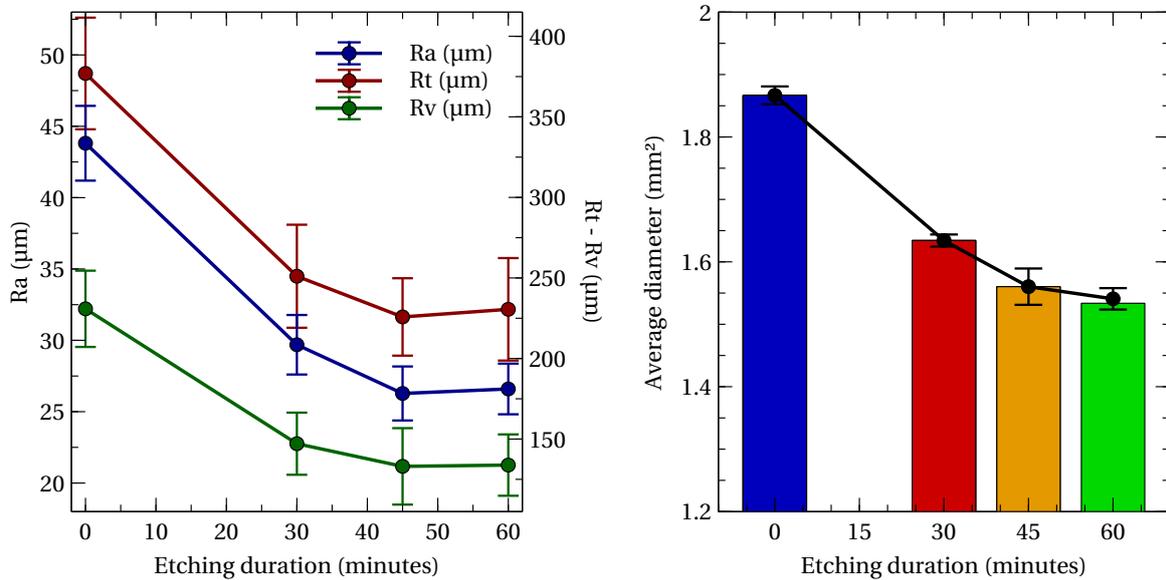
Figure 1.32: (a) Evolution of the roughnesses (R_a and R_t) with chemical etching duration. (b) Evolution of the volume in the sample’s cylindrical zone with chemical etching duration. (Error bars represent the standard deviation of the measurements.)

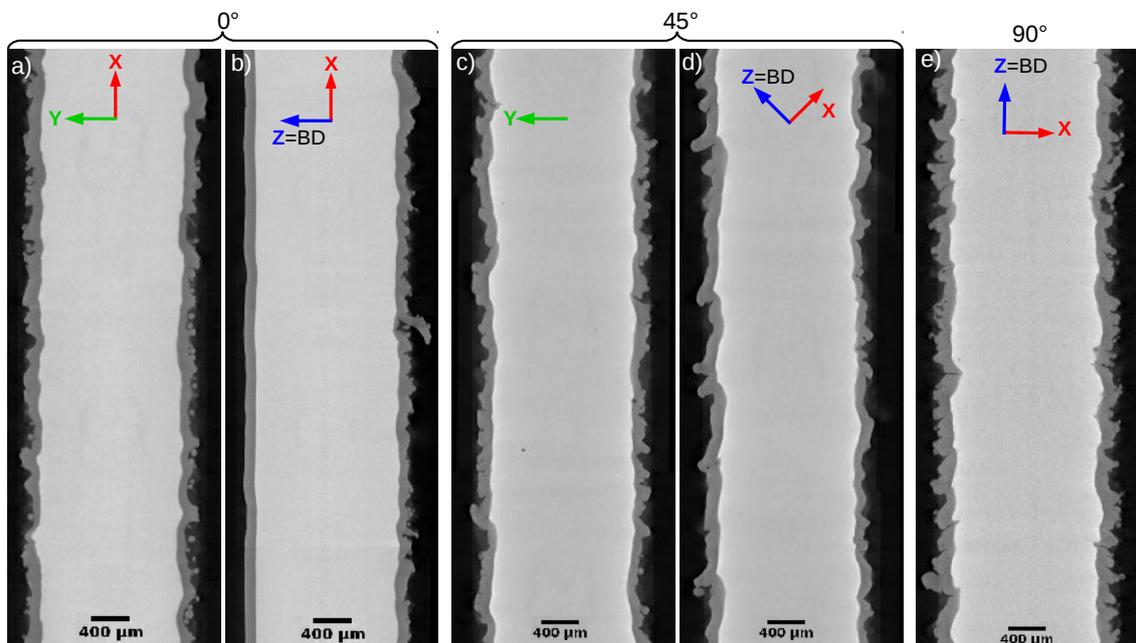
Figure 1.34: Effect of 45 minutes of chemical etching on the surface of the gauge length of as-built specimens built in the three different orientations. Dark gray: sample cross section before etching; light gray: after etching. Radial slices of samples manufactured respectively at 0° (a and b), 45° (c and d) and 90° (e). The building direction is indicated by blue arrows.

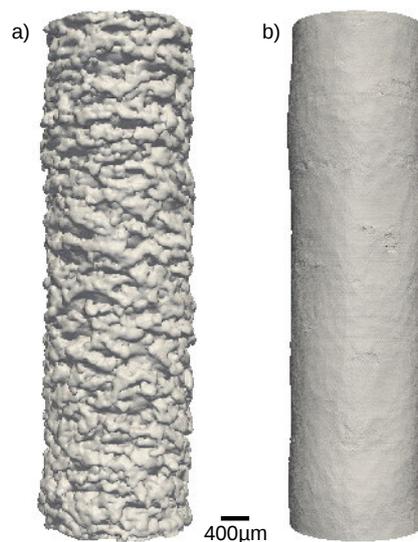
Figure 1.36: 3D renderings reconstructed from X-ray tomography scans of a sample gauge length portion before (a) and after (b) USP. After the USP treatment, the sample presents a surface state close to the one obtained by machining.

It has been shown in the previous sections that 90° samples exhibit more and deeper surface defects than the other build orientations both in the as-built state and after chemical etching. It was then chosen to apply ultrasonic shot peening only on 90° samples as they are the worst case scenario. An illustration of the effect of USP on the geometry of a 90° sample is shown in Figure 1.36.

When looking at Figure 1.36, the improvement of the surface state is rather impressive: after USP, the surface is very smooth and looks comparable to machined surfaces. This means that the plastic deformation induced by the impacts of the steel balls has enough energy to fold the peaks of the as-built state over the neighboring valleys and thus greatly smooth the surface. This efficiency of the process is confirmed by the 2D comparison of

Regarding the surface, the improvement observed on the 3D views (Figure 1.36) and 2D slices (Figure 1.37) leads to a large roughness reduction. The three roughness measurements (R_a , R_t and R_v) have been decreased by approximately 65 % (Table 1.8). Nevertheless, better roughness values were expected considering the surface aspect shown in Figure 1.36 and Figure 1.37. For instance, similar average R_a values are obtained for 90° USP treated and 0° chemically etched samples ($R_a=15.7$ and 16.1 μm respectively) whereas a clear improvement of the surface state can be observed, see Figure 1.34a and

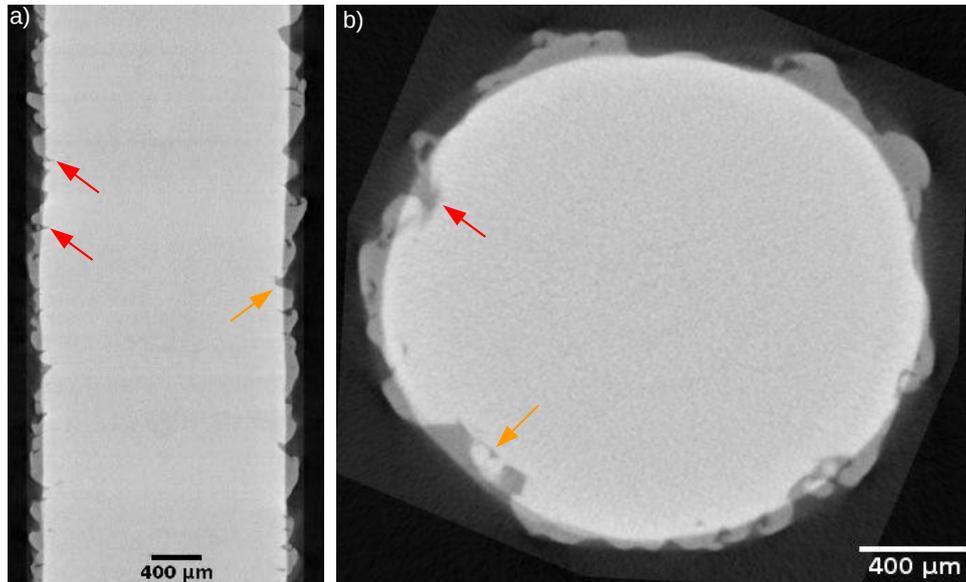
Figure 1.37: Effect of ultrasonic shot peening on the surface of the gauge length of as-built specimens (90° samples). Overlay of radial (a) and axial (b) slices. The dark gray areas show the peaks and valleys of the as-built state. Red and orange arrows respectively show notch-like defects and plate-pile like stacking defects.

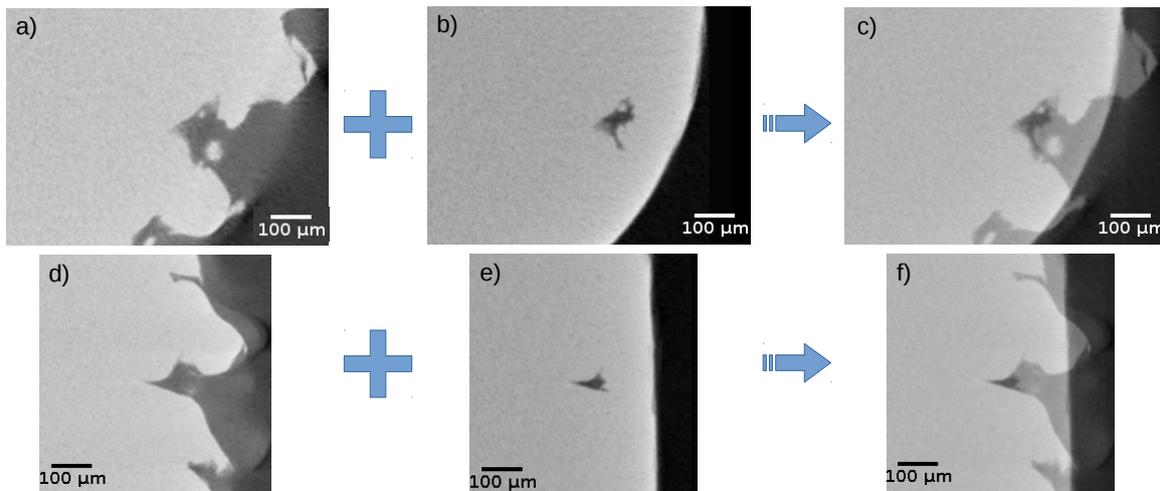
Figure 1.42: Effect of USP on notch-like defects at the surface of as-built specimens. (a, b and c) Axial slices representing respectively the notch in the as-built state, the corresponding internal defect after USP and the overlay of both states. (d, e and f) Radial slices representing respectively the notch in the as-built state, the corresponding internal defect after USP and the overlay of both states.

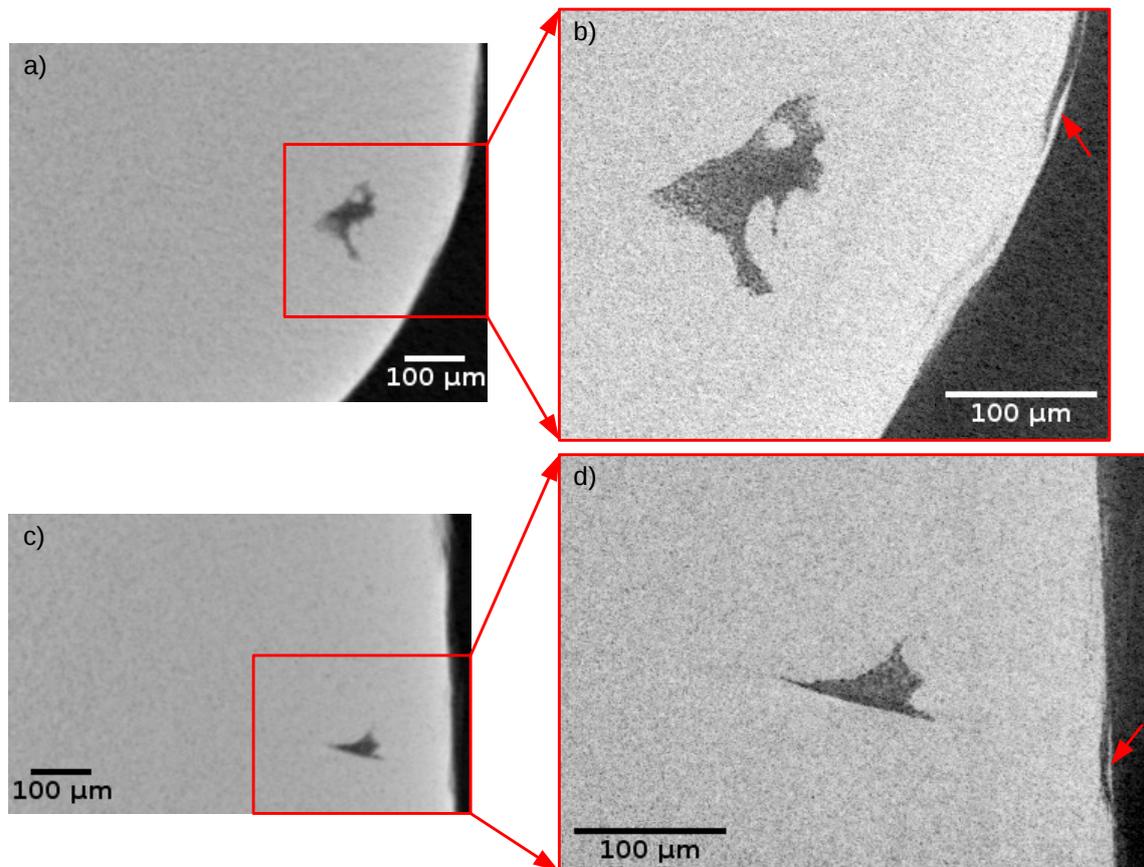
Figure 1.43: Impact of the tomography spatial resolution on the geometrical aspect of the defects. (a, b) Axial slices representing the detected defect using a voxel size of $2.5 \mu\text{m}$ and $1 \mu\text{m}$ respectively. (c, d) Radial slices representing the detected defect using a voxel size of $2.5 \mu\text{m}$ and $1 \mu\text{m}$ respectively. No gain of information appears despite the resolution improvement.

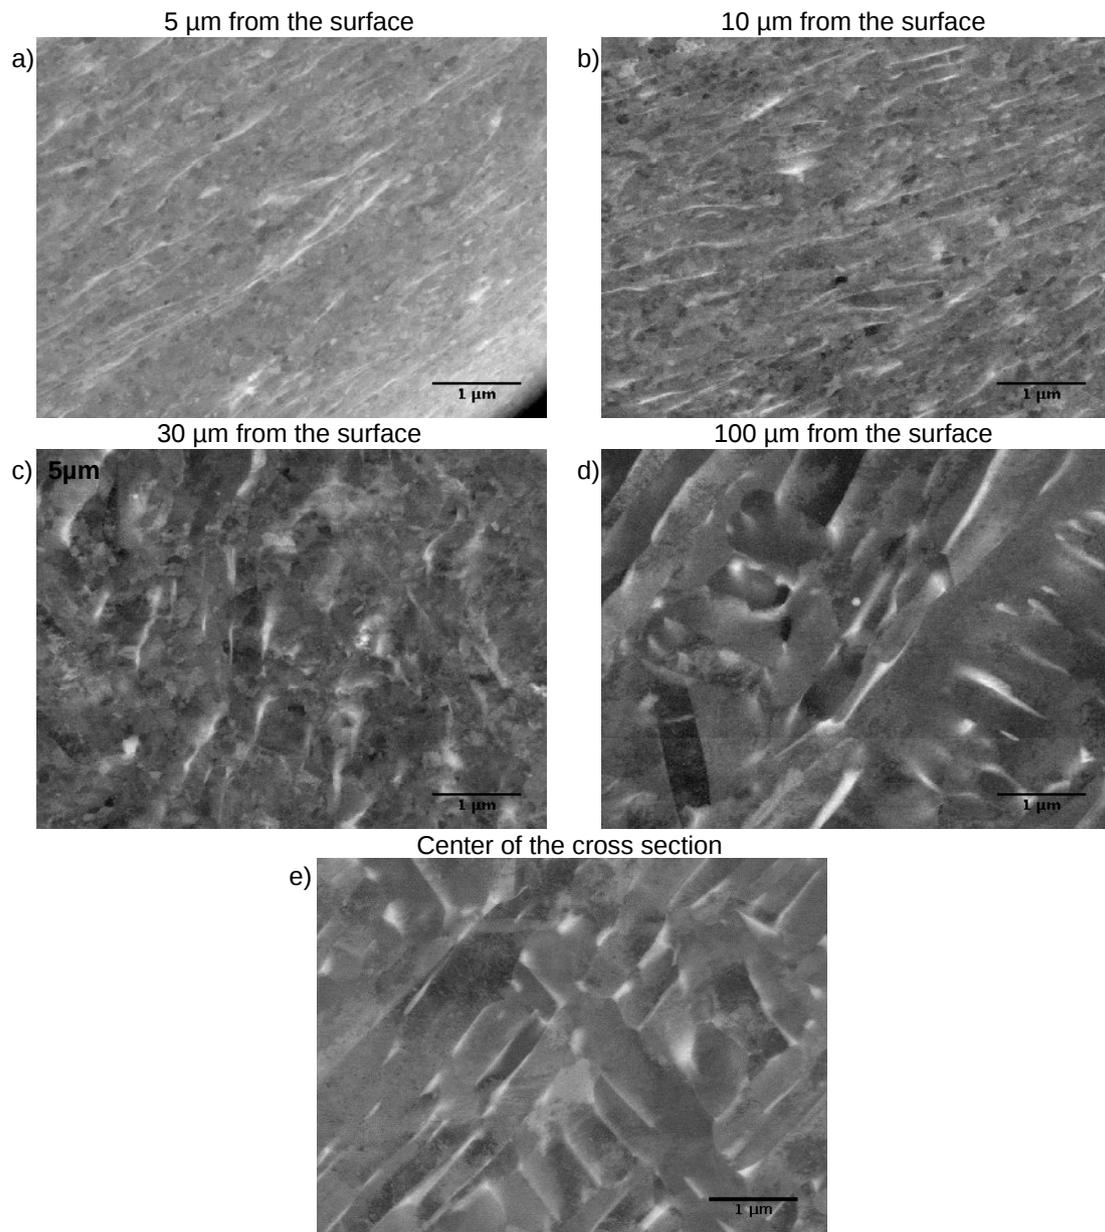
Figure 1.45: Evolution of the microstructure after USP from the surface to the center of the sample. SEM-BSE micrographs at higher resolution showing the microstructure of an as-built 90° EBM sample after USP treatment: $5 \mu m$ (a), $10 \mu m$ (b), $30 \mu m$ (c), $100 \mu m$ from the surface (d) and at the center of the cross section (e).

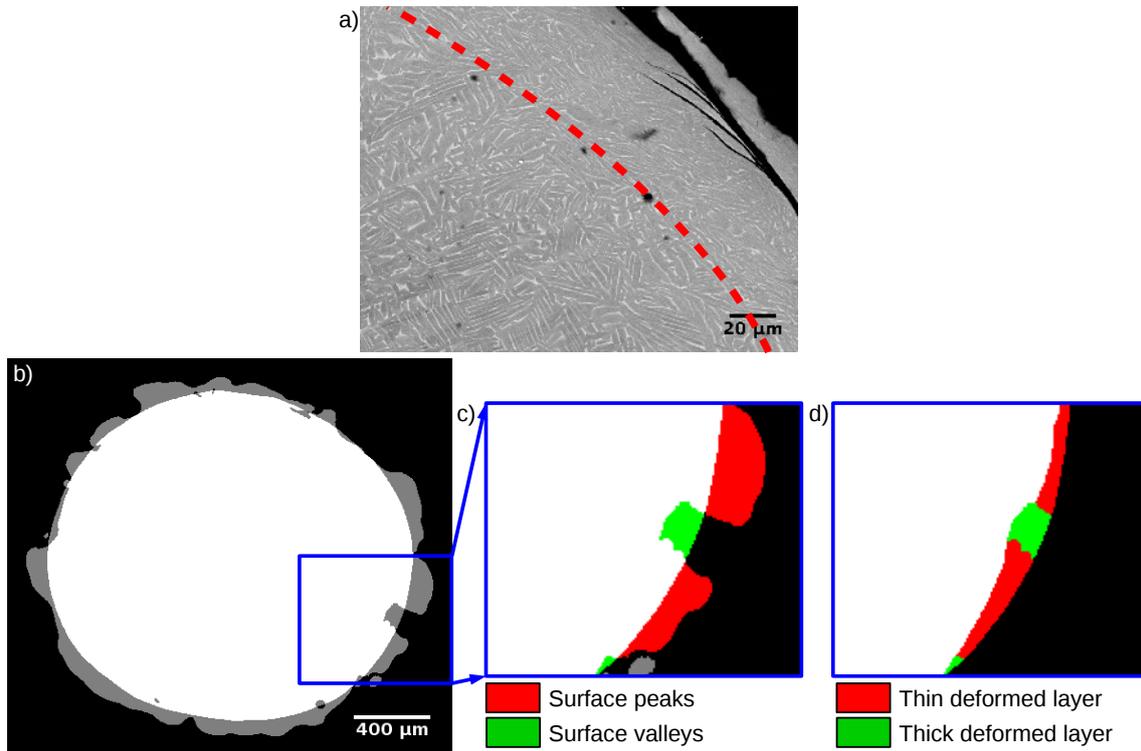
Figure 1.46: Origin of the uneven layer of deformed microstructure. (a) SEM-BSE micrograph of a HIP and USP treated sample showing the uneven layer. (b) Overlay of axial slices before and after USP. The intersection of both slices appears in white and its complementary part in gray. (c) Detailed view of a surface valley “filled” by USP (in green) and the surrounding peaks (in red). (d) Schematic illustration of the resulting deformed layer. Surface valleys lead to thick deformed layers (in green) whereas deformed peaks lead to thinner ones (in red).

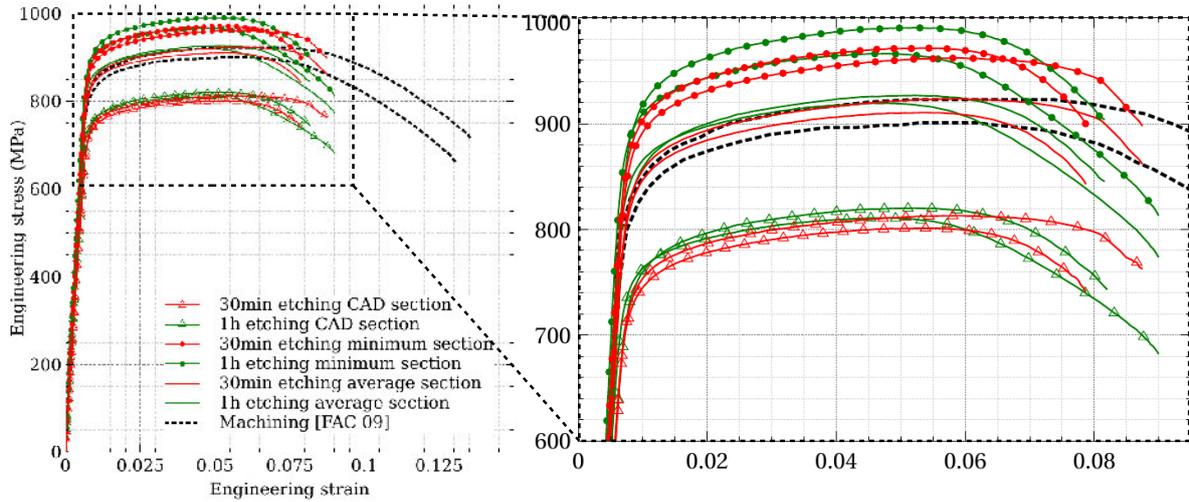
Figure 2.2: Engineering tensile stress-strain curves for samples fabricated by EBM after 30 (in red) and 60 minutes (in green) of chemical etching. The stresses are calculated with the CAD section (triangles symbols) or with the minimum section (dotted curves) or with the average section (continuous line). The black dashed curves correspond to data from Facchini et al. [FAC 09].

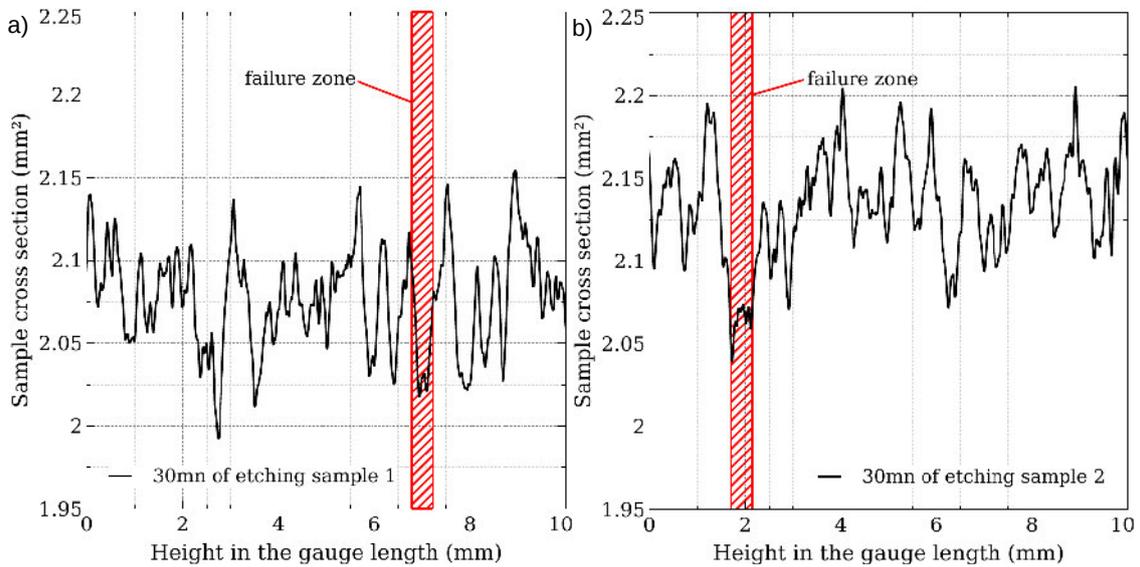
Figure 2.4: Example of variations of the cross section along the gauge length for two samples chemically etched for 30 minutes. The region highlighted in red represents the height at which failure occurred. For sample 2 shown in b), the minimum section is located inside the failure zone whereas this is not the case for sample 2 shown in a).

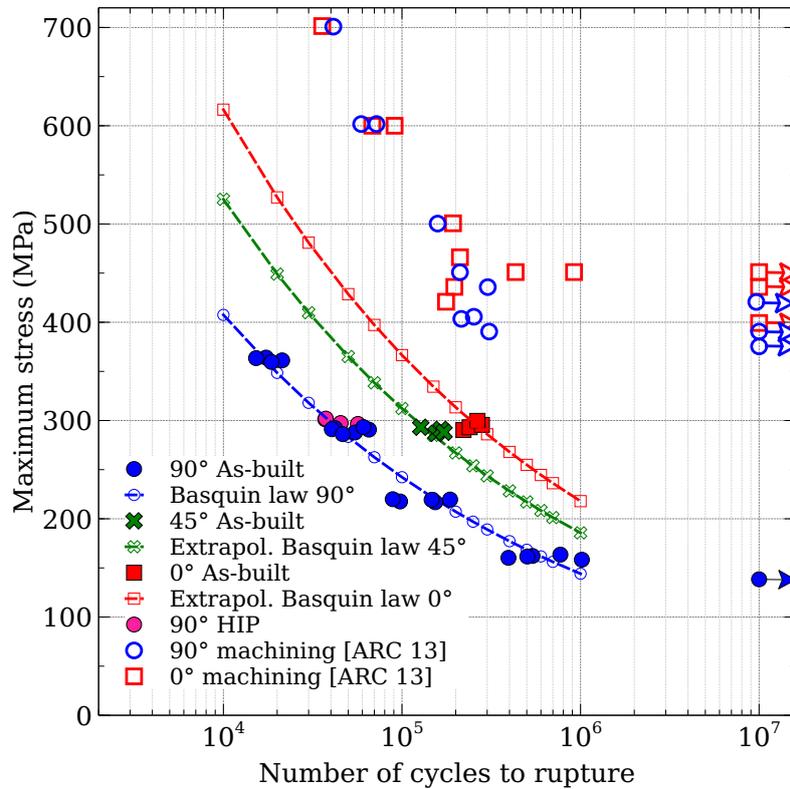
Figure 3.2: S-N curves for as-built fatigue samples fabricated by EBM with 3 different orientations: 0° (red squares), 45° (green crosses) and 90° (blue dots). Hollow symbols correspond to data from ARCAM [ARC 13] on machined samples obtained by EBM. Arrows show run out samples ($N > 10^7$ cycles). The Basquin law of the 90° samples is represented by a blue dashed line with dots and was used to extrapolate the ones of 0° (red dashed line with squares) and 45° samples (green dashed line with crosses). Details regarding the extrapolation are provided in section 3.4.5.2.

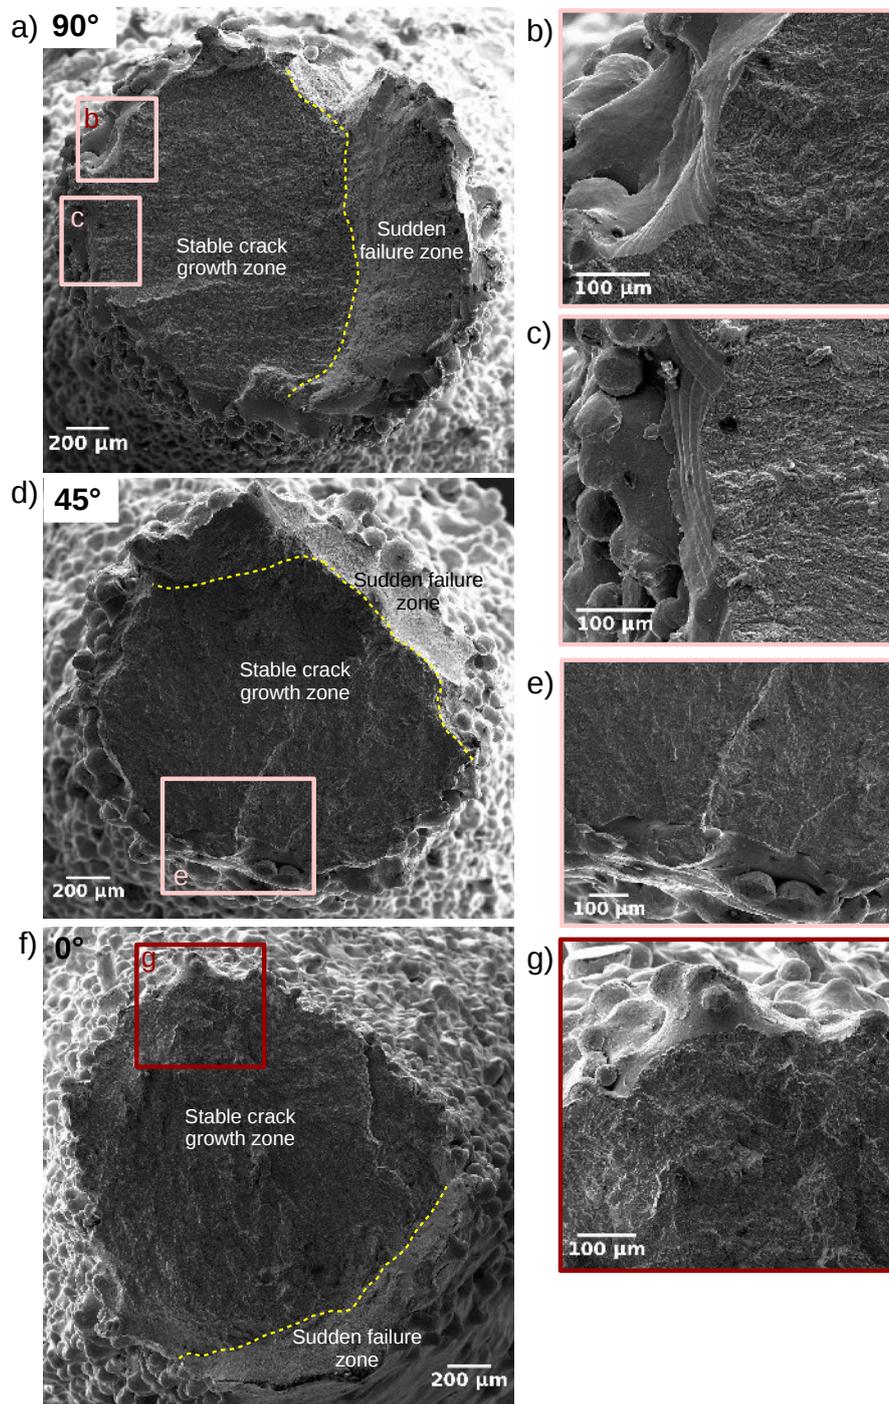
Figure 3.3: SEM-SE micrographs of the fracture surfaces of as-built EBM fatigue samples ($\sigma_{max} = 290$ MPa). (a,d,f) Fracture surfaces showing the stable crack growth and sudden failure zones of 90°, 45° and 0° samples respectively. (b,c,e,g) Higher magnification images showing the crack initiation sites.

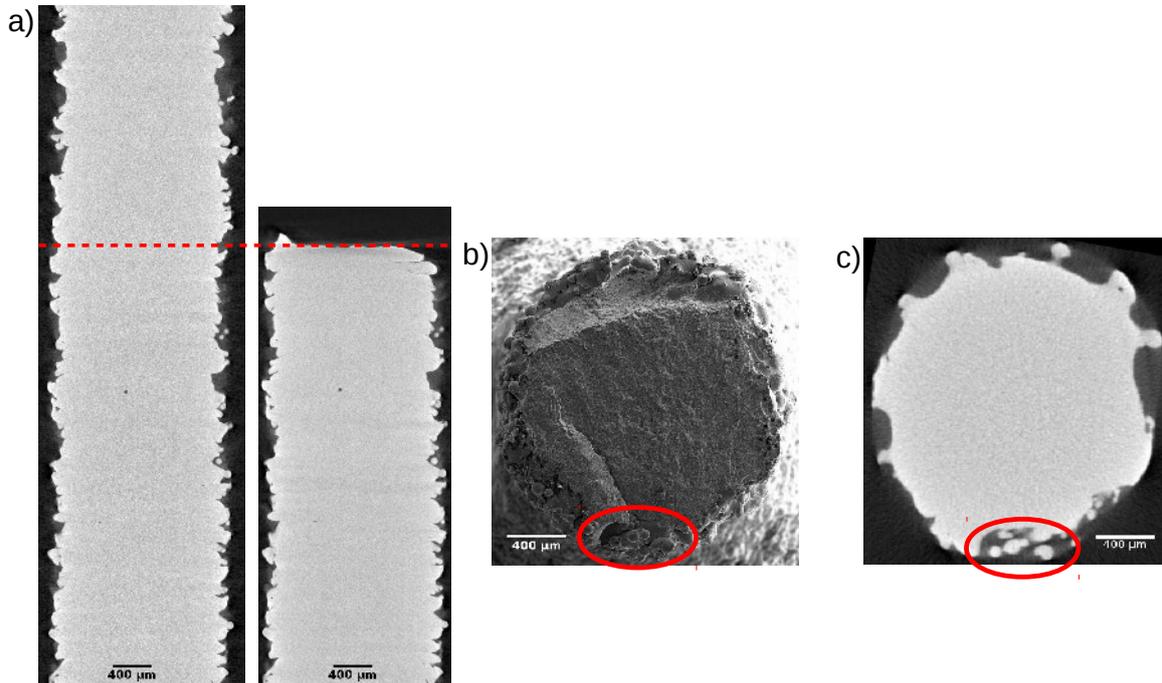
Figure 3.4: Schematic illustration of the methodology used to identify the defect responsible for the fatigue failure. (a) Radial slices obtained by X-ray tomography of a sample before and after fatigue failure. Their comparison enables to identify the critical cross section, i.e. the height within the gauge length at which failure occurred. (b) SEM-SE observation of the fracture surface of the fatigue sample. (c) Tomographic axial view of the sample cross section with the critical defect before fatigue test. Comparison of (b) and (c) leads undoubtedly to the critical defect identification.

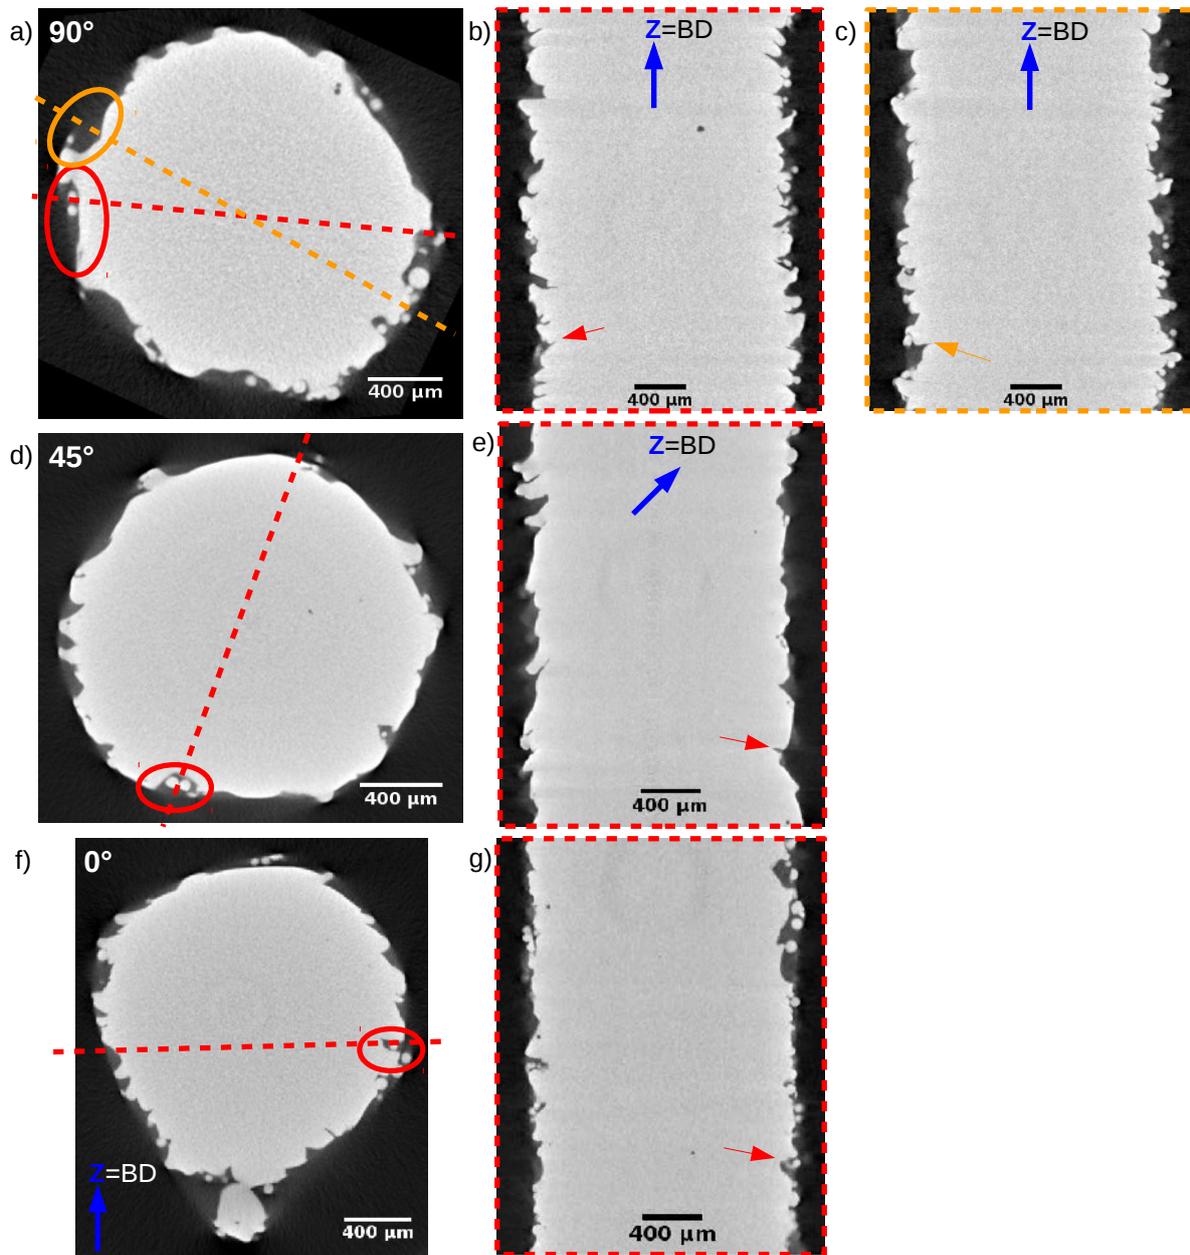
Figure 3.5: Examples of surface defects responsible for the failure of as-built samples (notch-like defects for 90° and 45° samples and a “plate-pile” like stacking defect for the 0° sample). (b,c,e,g) Radial slices of critical defects for respectively 90°, 45° and 0° sample. (a,d,f) Axial slices of critical defects for respectively 90°, 45° and 0° samples. (b,c,e,g) Radial slices of critical defects for respectively 90°, 45° and 0° samples. Arrows and ellipses highlight the critical defects. The dashed lines on the axial slices indicate the location of the corresponding radial slices. For each sample, the building direction is indicated by a blue arrow.

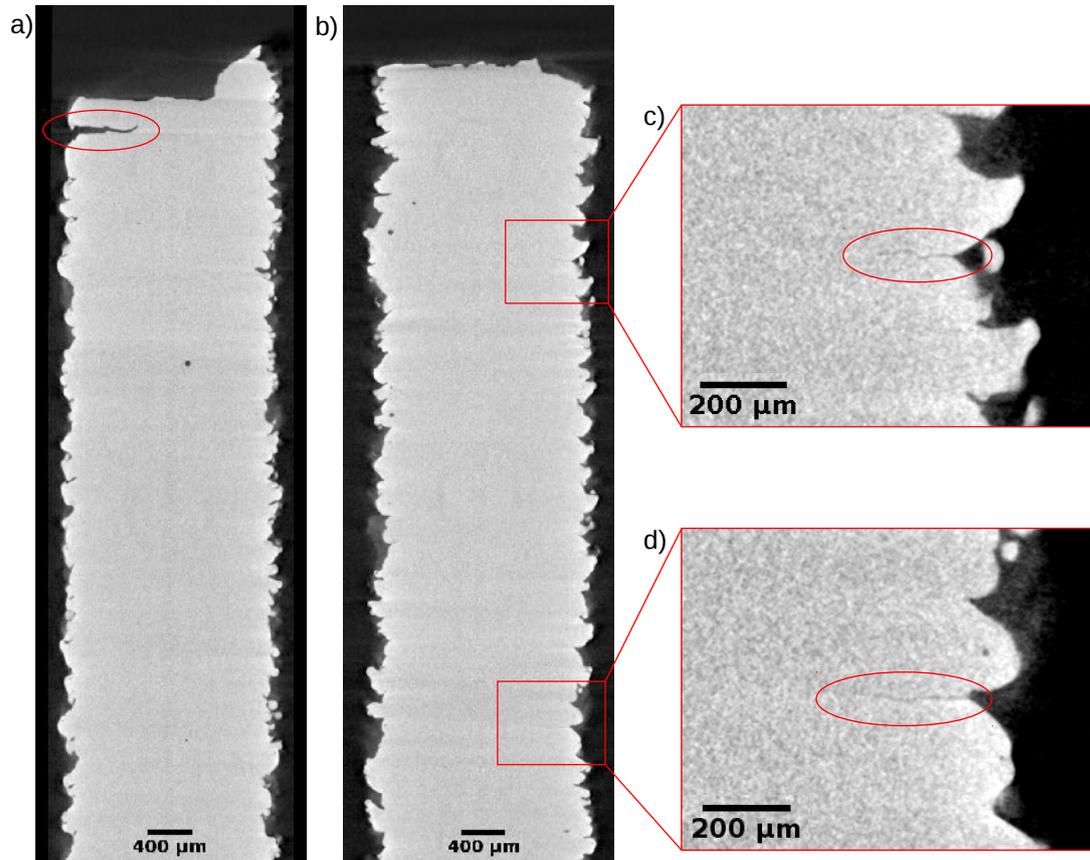
Figure 3.6: Examples of cracks detected outside the failure zone. The cracks are circled in red. (a,b) Radial slices showing a long crack close to the failure zone (a) and shorter cracks that propagated further away from the failure zone (b). (c,d) Enlarged view of the surface defects showing the short cracks. These tomographic slices correspond to samples tested at high stress levels: they lived respectively $\sim 47\,000$ and $\sim 15\,000$ cycles.

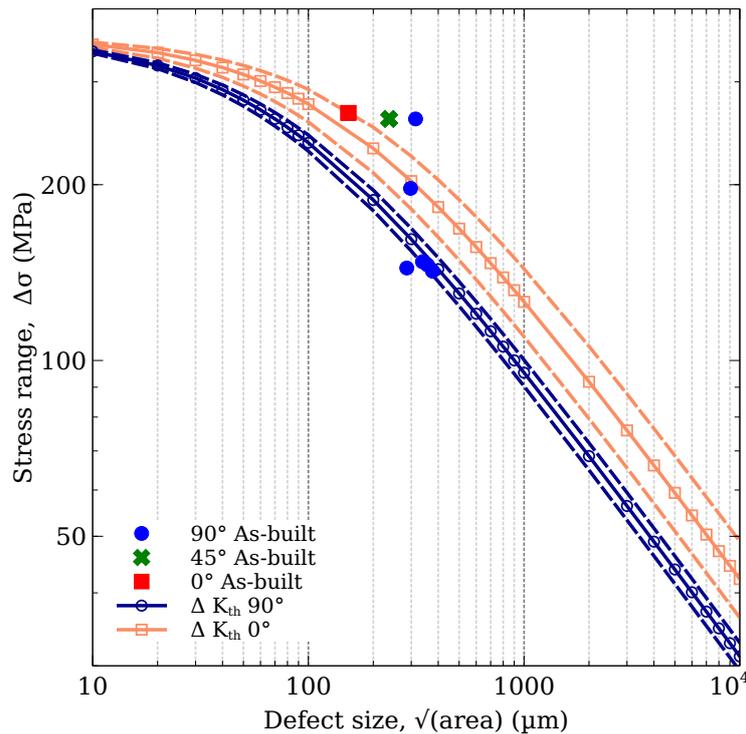
Figure 3.11: Classical *Kitagawa-Takahashi* diagram of as-built EBM Ti-6Al-4V alloy. The blue and red lines correspond respectively to notches perpendicular and parallel to the building direction. The continuous lines were plotted using the average ΔK_{th} value from the literature while minimum and maximum values were considered for the dashed lines. The blue dots, green crosses and red squares correspond respectively to the 90°, 45° and 0° samples. They were plotted using directly the experimental stress range $\Delta\sigma$ and the size \sqrt{area} of the defect responsible for the failure measured on the SEM-SE micrograph of the fracture surface.

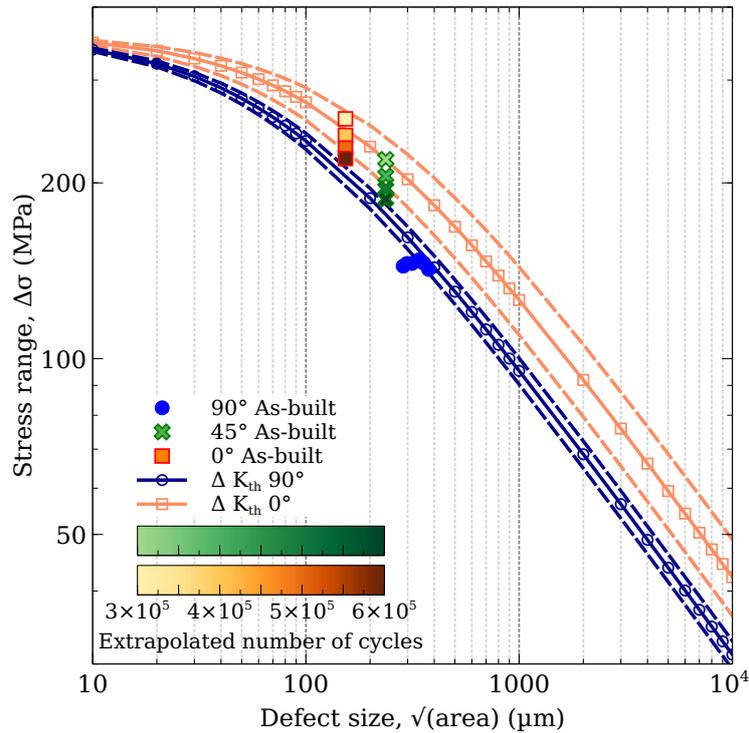
Figure 3.12: Modified *Kitagawa-Takahashi* diagram of as-built EBM Ti-6Al-4V alloy following the method suggested by Beretta and Romano [BER 17]. The blue and red lines correspond respectively to notches perpendicular and parallel to the building direction. The continuous lines were plotted using the average ΔK_{th} value from the literature while minimum and maximum values were considered for the dashed lines. The blue dots, green crosses and red squares correspond respectively to the 90°, 45° and 0° samples for which the size of the defect responsible for the failure was measured on SEM-SE micrographs of the fracture surfaces. Their stress range was extrapolated to larger fatigue lives corresponding to the knee-point of the Wöhler curve.

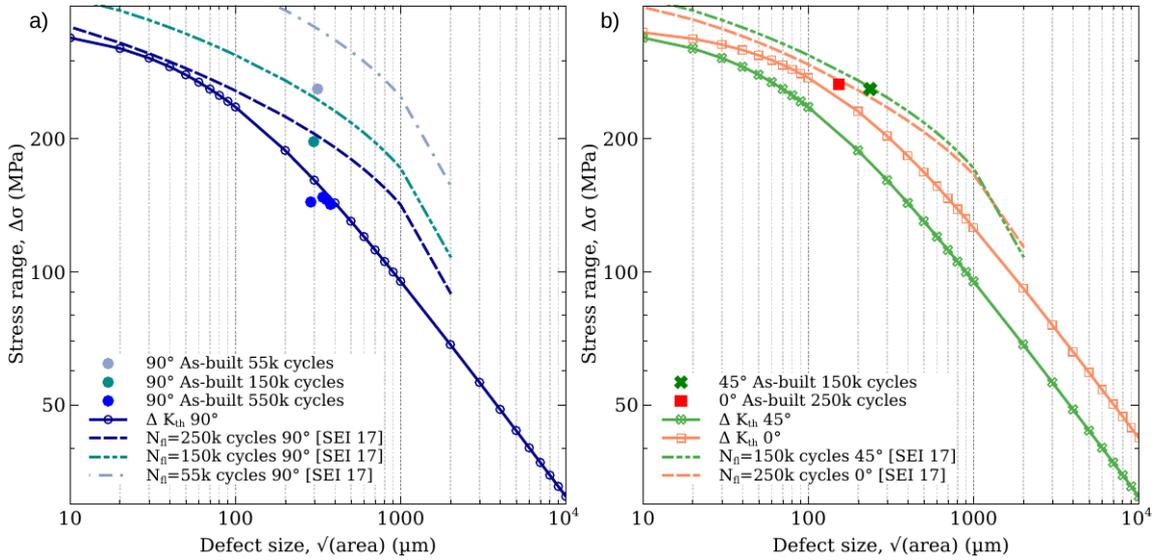
Figure 3.13: Modified *Kitagawa-Takahashi* diagrams of as-built EBM Ti-6Al-4V alloy extended to finite lives following the approach of Ciavarella and Monno [CIA 06]. The continuous dotted lines were plotted using the average ΔK_{th} value from the literature. Each dashed curve corresponds to a given number of cycles N_{fl} and relies on the stress amplitude corresponding to N_{fl} as well as a propagation law and a fracture toughness value K_{1c} . The experimental stress range was directly used for the blue dots, green crosses and red squares. (a) Diagram for 90° samples. (b) Diagram for 0° and 45° samples.
