Fatigue of Ti-6Al-4V thin parts made by electron beam melting

THESE de DOCTORAT DE L'UNIVERSITE DE LYON
opérée au sein de
L'Institut National des Sciences Appliquées de Lyon

**Fatigue of Ti-6Al-4V thin parts made by
Electron Beam Melting**

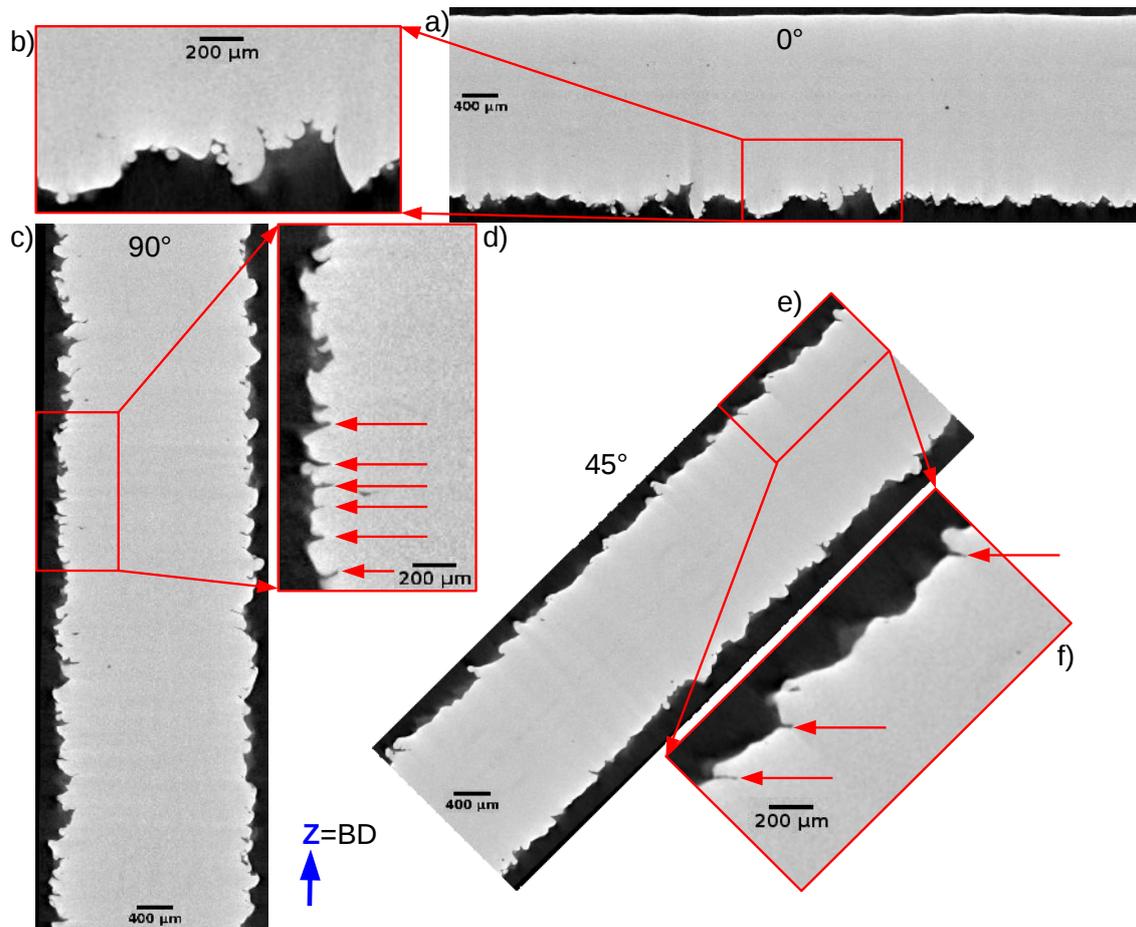
Figure 3.14: Impact of the build orientation on the surface of the samples gauge length. (a,c,e) Radial slices of samples manufactured respectively at 0° , 45° and 90° . (b,d,f) Magnification around surface defects. The slices are oriented in order to mimic the sample orientation in the build chamber, the building direction being vertical (blue arrow).

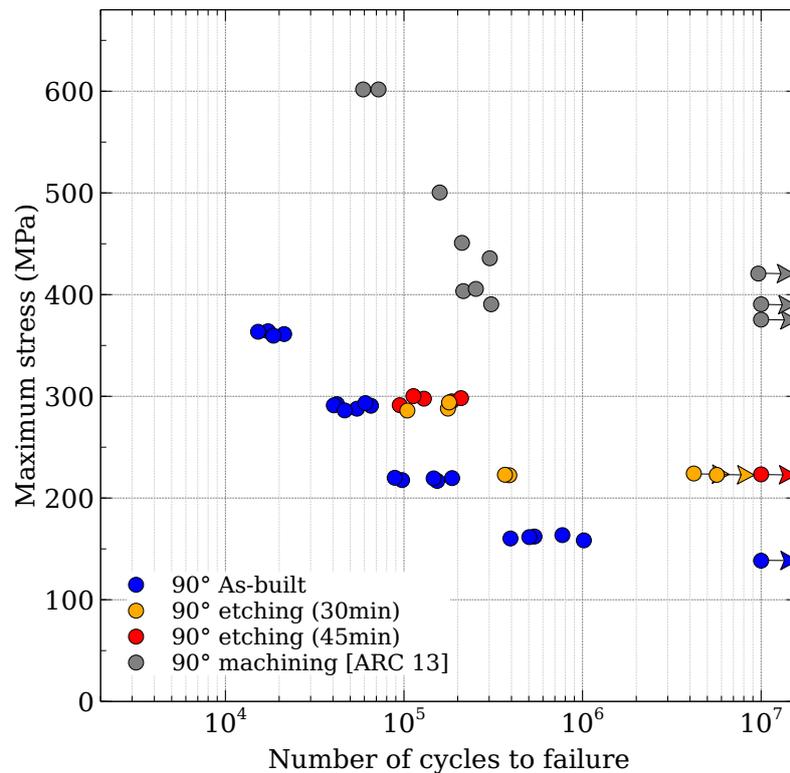
Figure 3.15: S-N curves for EBM 90° fatigue samples in the as-built conditions (blue dots) and after 30 minutes (orange dots) and 45 minutes (red dots) of chemical etching. Grey symbols correspond to data from ARCAM [ARC 13] on 90° machined samples manufactured by EBM.

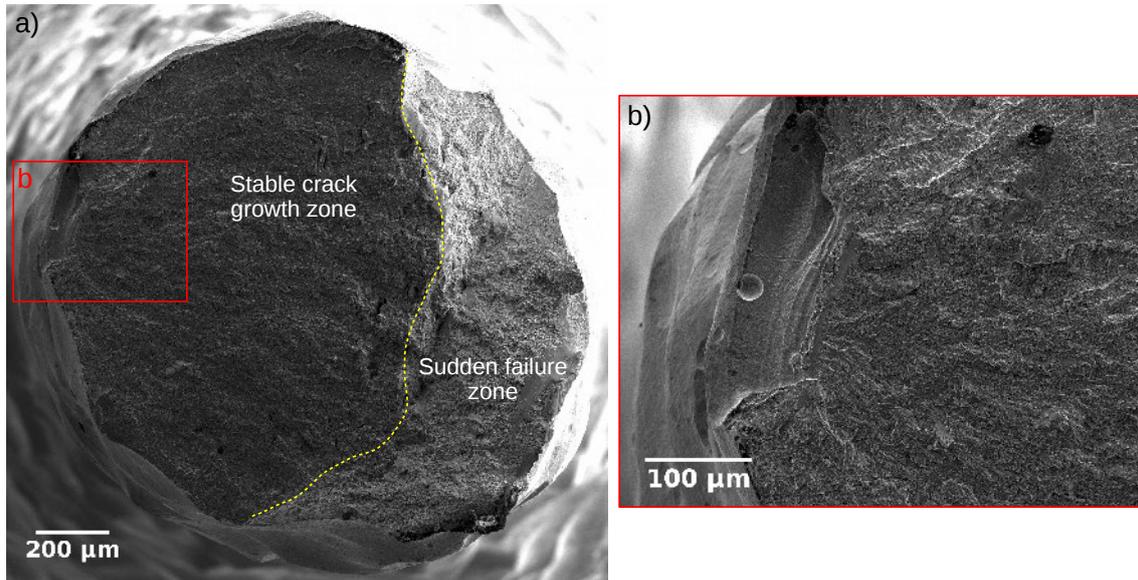
Figure 3.16: SEM-SE micrographs of the fracture surface of a chemically etched 90° EBM fatigue sample. (a) Fracture surface showing the stable crack growth and sudden failure zones. (b) Higher magnification image showing the crack initiation site.

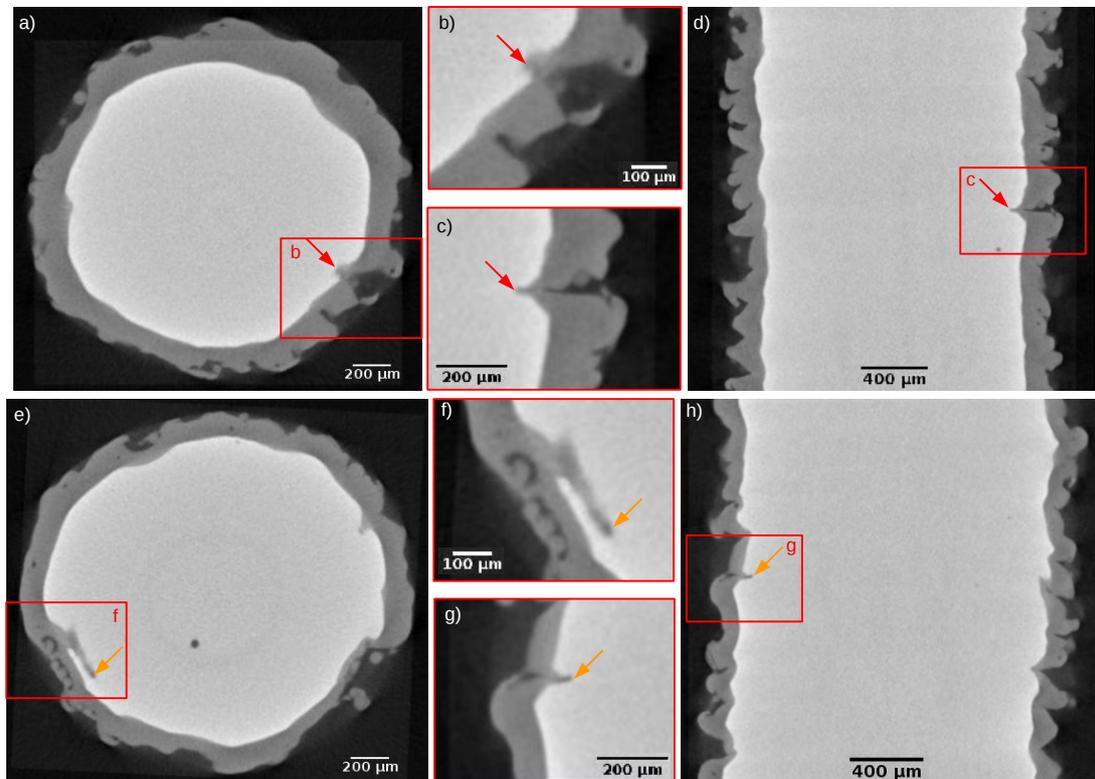
Figure 3.18: Effect of chemical etching on two notch-like defects (a-d and e-h) leading to fatigue failure. Dark gray: sample slices in the as-built state. Light gray: sample slices after 45 minutes of chemical etching. (a,e) Overlaps of the axial slices showing two critical defects before and after 45 minutes of chemical etching. (d,h) Overlaps of the corresponding radial slices before and after 45 minutes of chemical etching. (b,c,f,g) Detailed views of the defects shown in respectively a, d, e and h. The red and orange arrows point out the root of respectively the first and second notch-like defects.

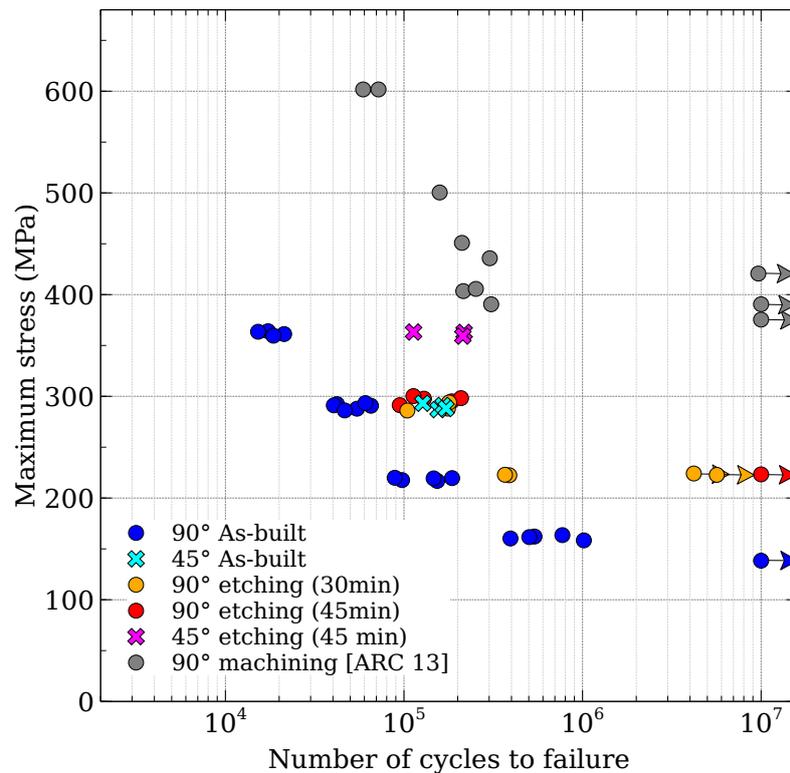
Figure 3.19: S-N curves for EBM 45° and 90° fatigue samples in the as-built conditions and after chemical etching. The dots and crosses correspond respectively to 90° and 45° samples. The blue colors (blue and cyan) depict the as-built conditions and the chemically etched one is represented by the orange (30 minutes), red and pink (both 45 minutes) symbols. Grey symbols correspond to data from ARCAM [ARC 13] measured on 90° machined samples.

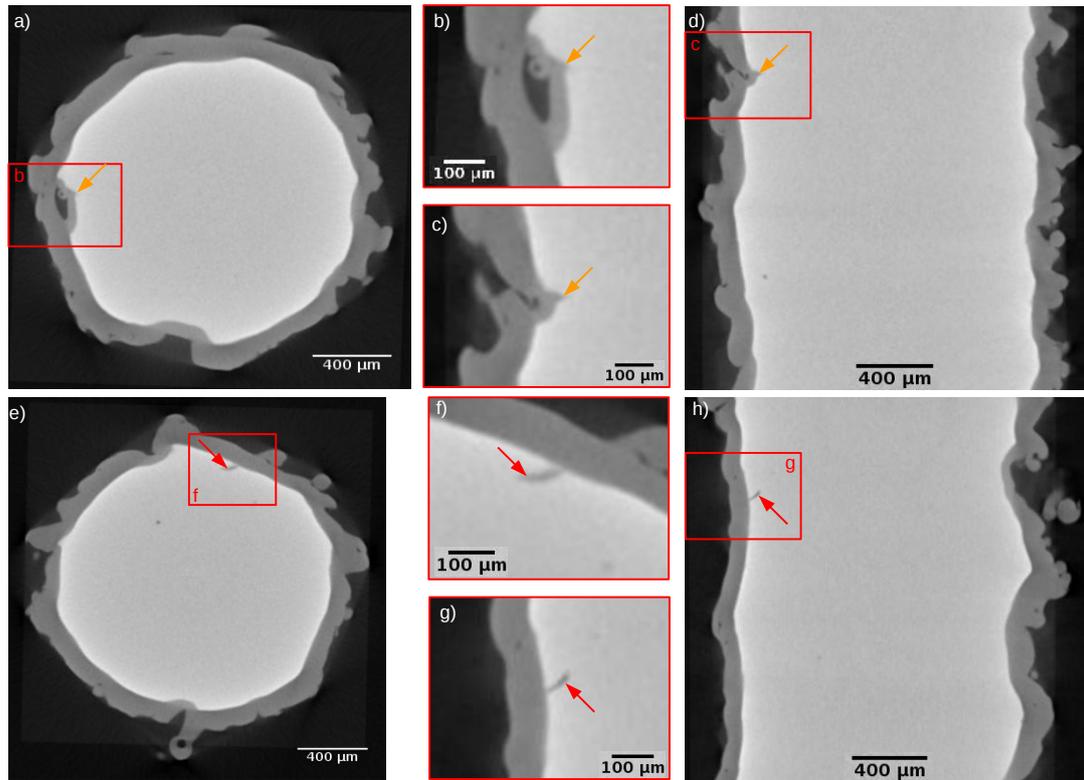
Figure 3.20: Example of two defects leading to the fatigue failure of 45° samples chemically etched for 45 minutes: the remaining part of a notch-like defect (a-d) and an internal lack-of-fusion defect connected to the surface after chemical etching (e-h). Dark gray: sample slices in the as-built state. Light gray: sample slices after 45 minutes of chemical etching. (a,e) Overlaps of the axial slices showing two critical defects before and after 45 minutes of chemical etching. (d,h) Overlaps of the corresponding radial slices before and after 45 minutes of chemical etching. (b,c,f,g) Detailed views of the defects represented in respectively a, d, e and h. The orange and red arrows respectively point out the first and second defects.

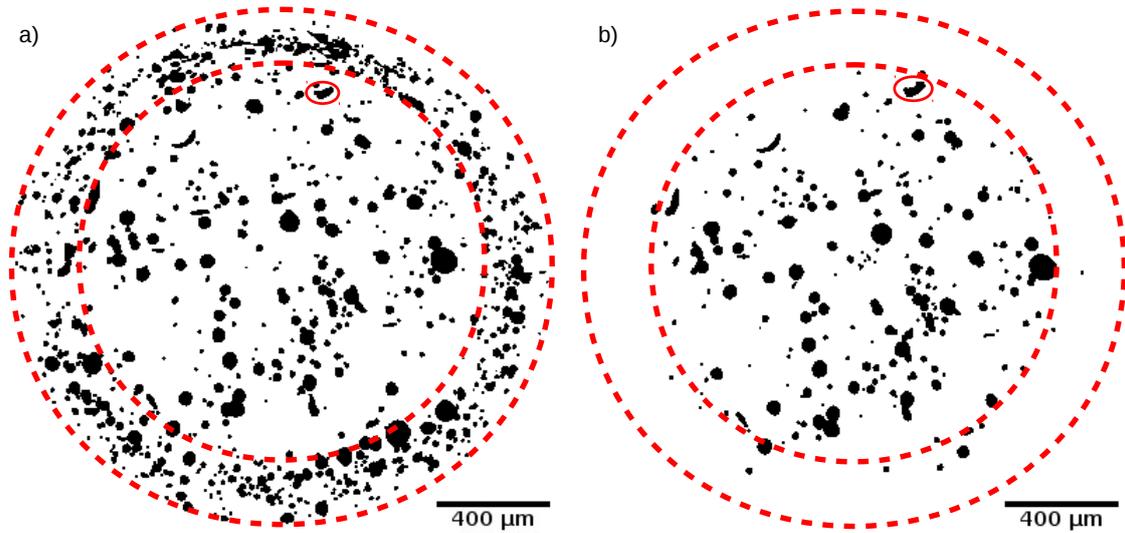
Figure 3.21: Projected view of all the internal defects detected by X-ray lab tomography ($2.5 \mu\text{m}$ voxel size) within the gauge length of the 45° sample presented in Figure 3.20e-h in the as-built (a) and chemically etched (b) conditions. The defect responsible for the sample failure is circled in red and has been added to the projection after chemical etching. The sub-surface ring with a higher density of internal defects is highlighted by the two red dashed circles.

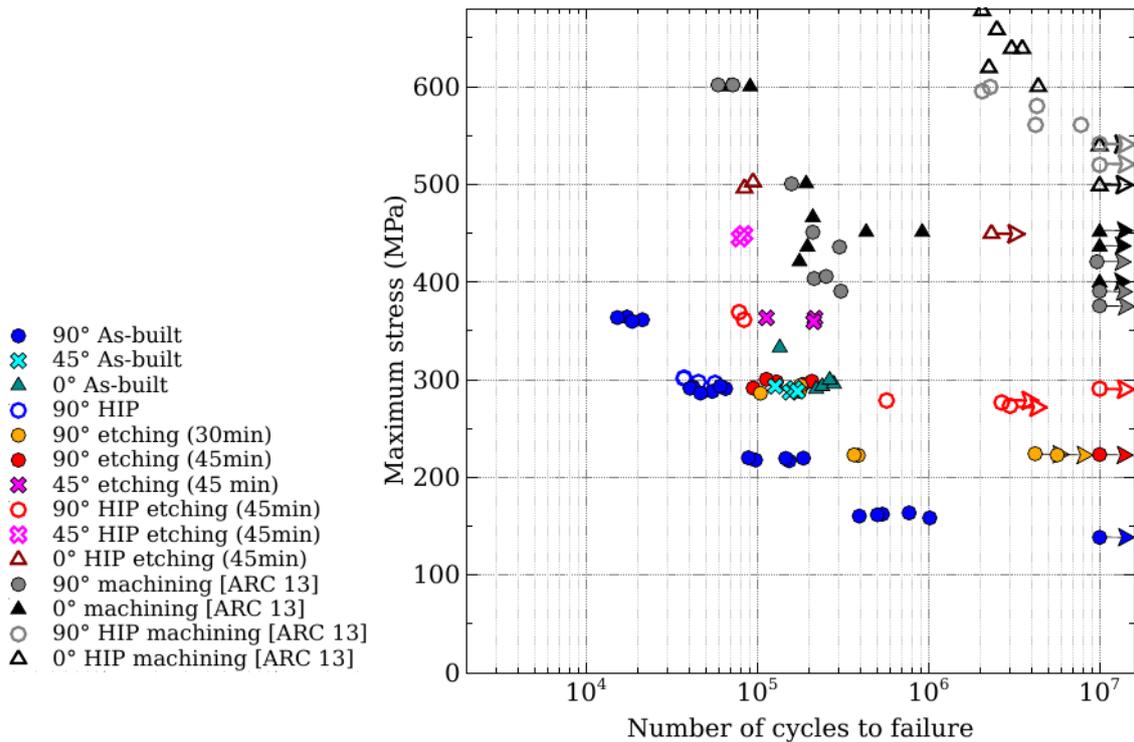
Figure 3.22: S-N curves for EBM 0° (triangles), 45° (crosses) and 90° (dots) fatigue samples. The blue colors (blue, cyan and dark cyan) depict the as-built state. The chemically etched samples are represented by the orange (30 minutes), red, pink and dark red (both 45 minutes) colors. Hollow symbols stand for samples for which HIP was applied. Grey and black symbols correspond to data from ARCAM [ARC 13] on respectively 90° and 0° machined samples obtained by EBM.

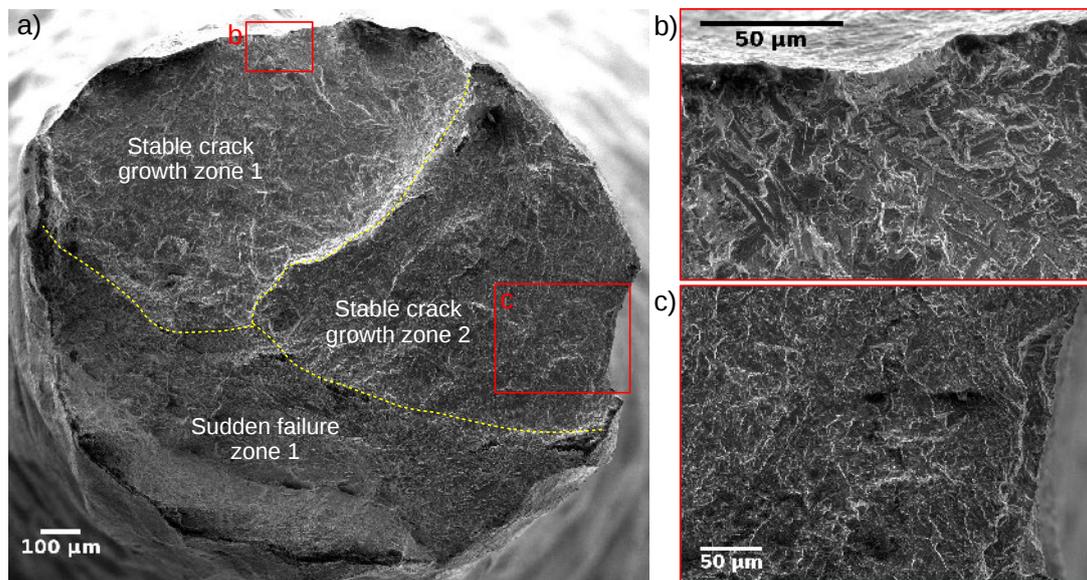
Figure 3.23: SEM-SE micrographs of the fracture surface of one 45° EBM fatigue sample after HIP and chemical etching. (a) Fracture surface showing the stable crack growth and sudden failure zones. (b,c) Higher magnification image showing the crack initiation sites.

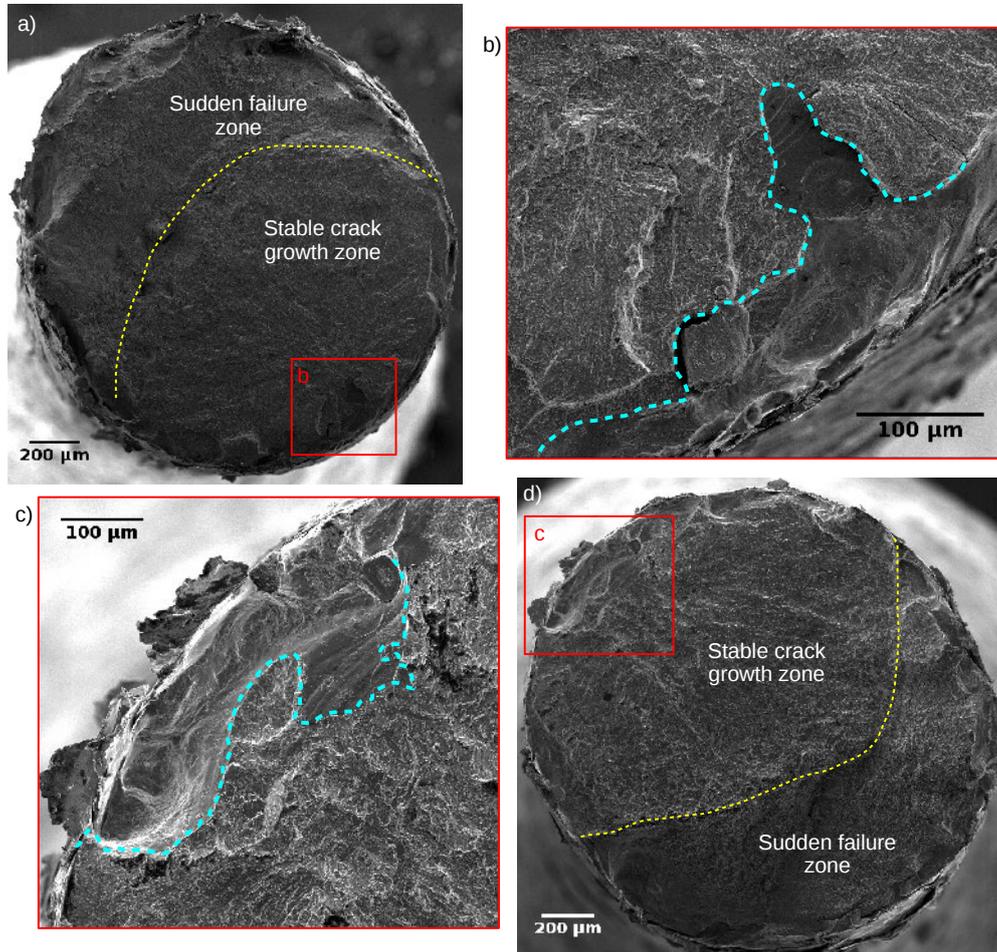
Figure 3.27: SEM-SE micrographs of the fracture surfaces of two 90° EBM fatigue samples: one USP treated (a,b) and one HIP and USP treated (c,d). (a,d) Fracture surface showing the stable crack growth and sudden failure zones. (b,c) Higher magnification image showing the crack initiation sites. Their inner contour is delineated by a blue dashed line.

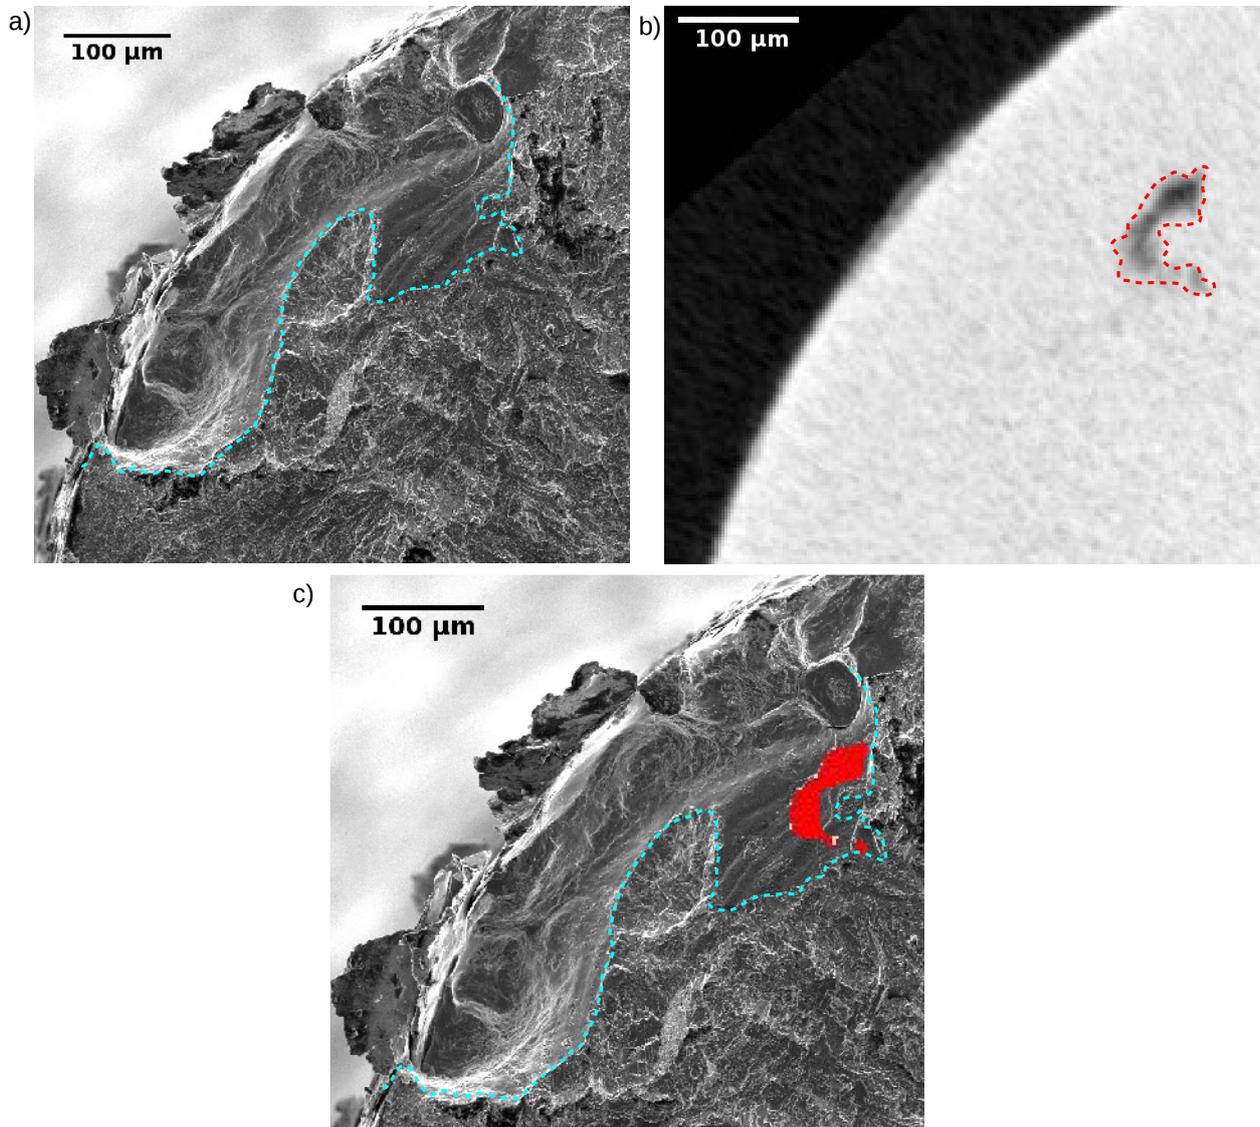
Figure 3.28: Comparison of the high magnification SEM-SE micrograph (a) of the crack initiation site of one HIP and USP treated sample with the corresponding tomographic image (b). (b) Axial view of the critical defect after USP treatment as observed on tomographic images. (c) Overlap of the SEM and tomographic images. The defect detected by tomography is shown in red and the inner contour of the one detected by SEM-SE is delineated by a blue dashed line.

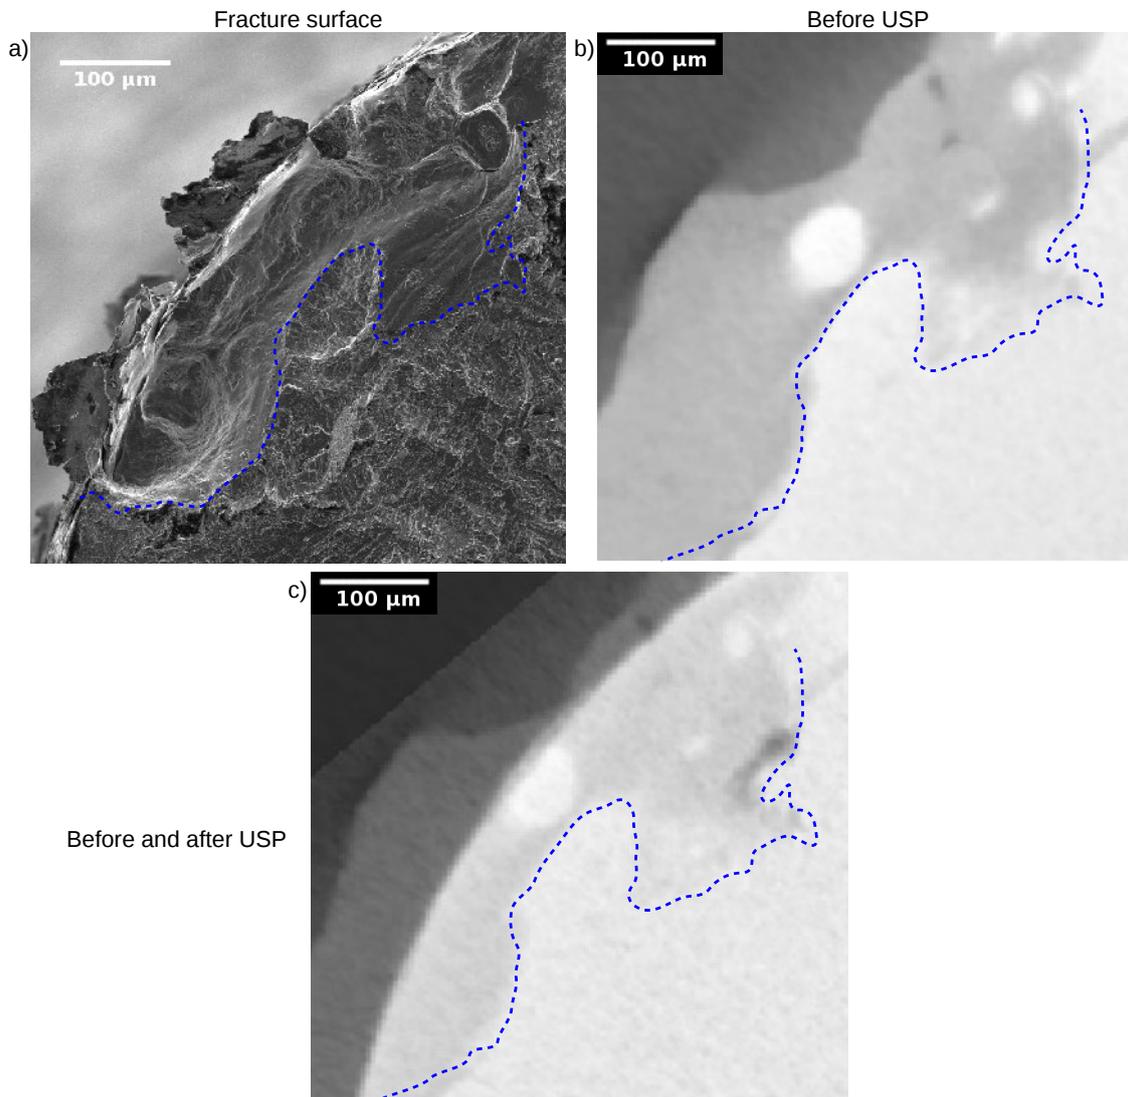
Figure 3.29: Comparison of the high magnification SEM-SE micrograph (a) of the crack initiation site of one HIP and USP treated sample with the corresponding tomographic image in the as-built state (b). The inner contour of the surface defect is highlighted by the blue dashed line. (b) Average computation of the minimum (light gray area) and maximum (combined dark and light gray areas) projections along the loading axis around the critical defect. (c) Average computation of (b) with the tomographic image of the critical defect after USP.

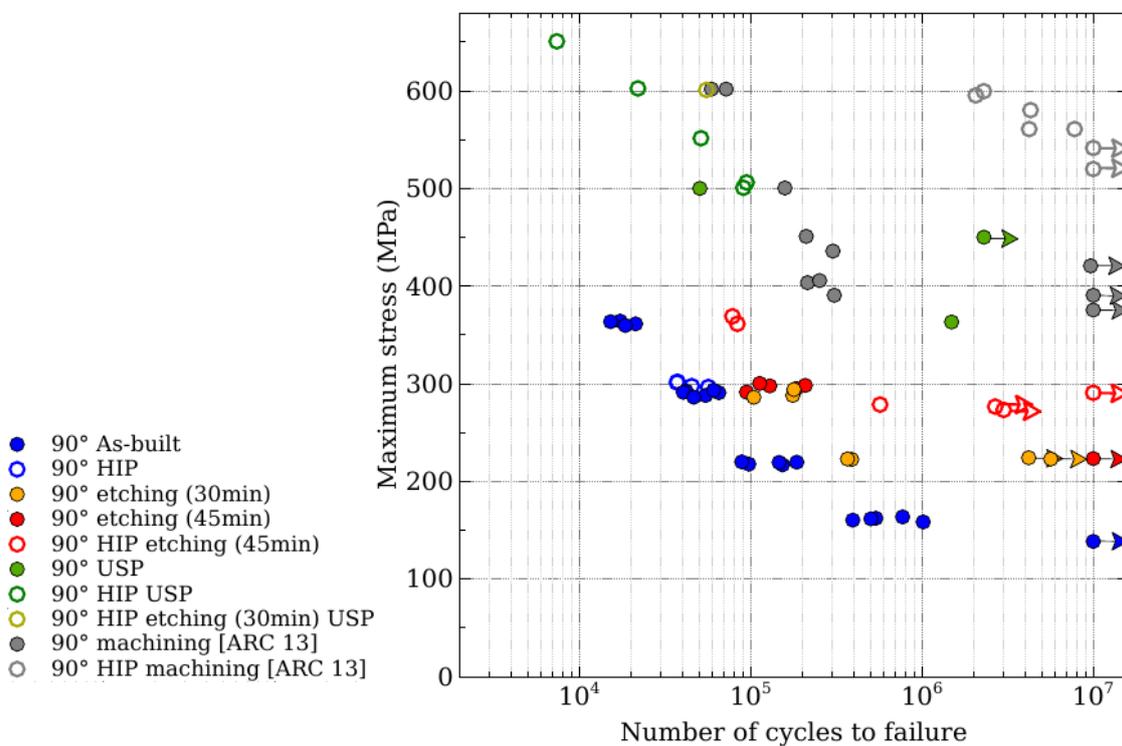
Figure 3.30: S-N curves for EBM 90° fatigue samples in the as-built state (blue dots), after 30 minutes (orange dots) and 45 minutes (red dots) of chemical etching and after 2 hours of USP (green dots). Grey symbols correspond to data from ARCAM [ARC 13] on 90° machined samples obtained by EBM. Hollow symbols represented HIP treated samples. The light green hollow dot represents the sample submitted to HIP + chemical etching + USP.

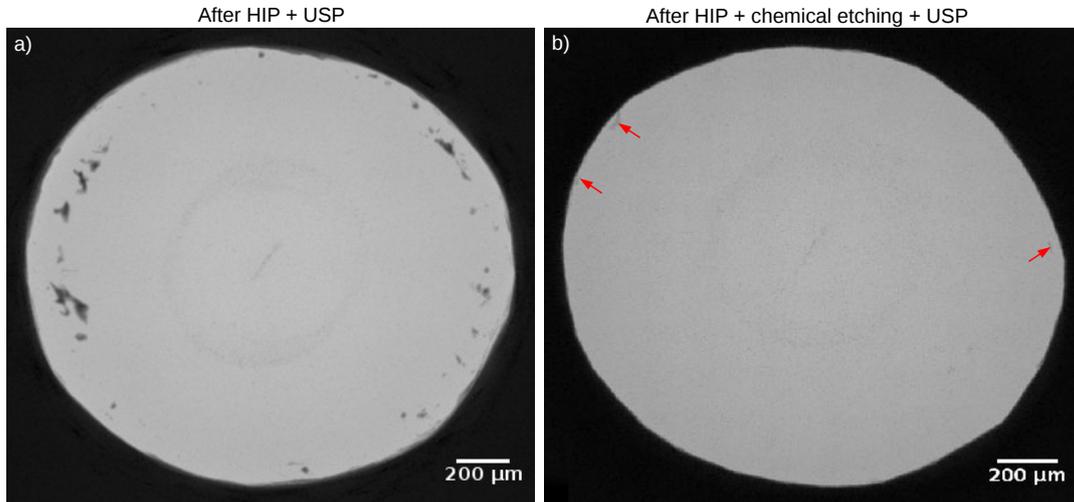
Figure 3.31: Minimum projections of all the X-ray lab tomographic axial slices ($2.5 \mu\text{m}$ voxel size) within the gauge length of a “HIP + USP treated” sample (a) and a sample that underwent successively HIP, chemical etching and USP post-treatments (b). The detected defects appear in dark gray and are pointed out by red arrows.

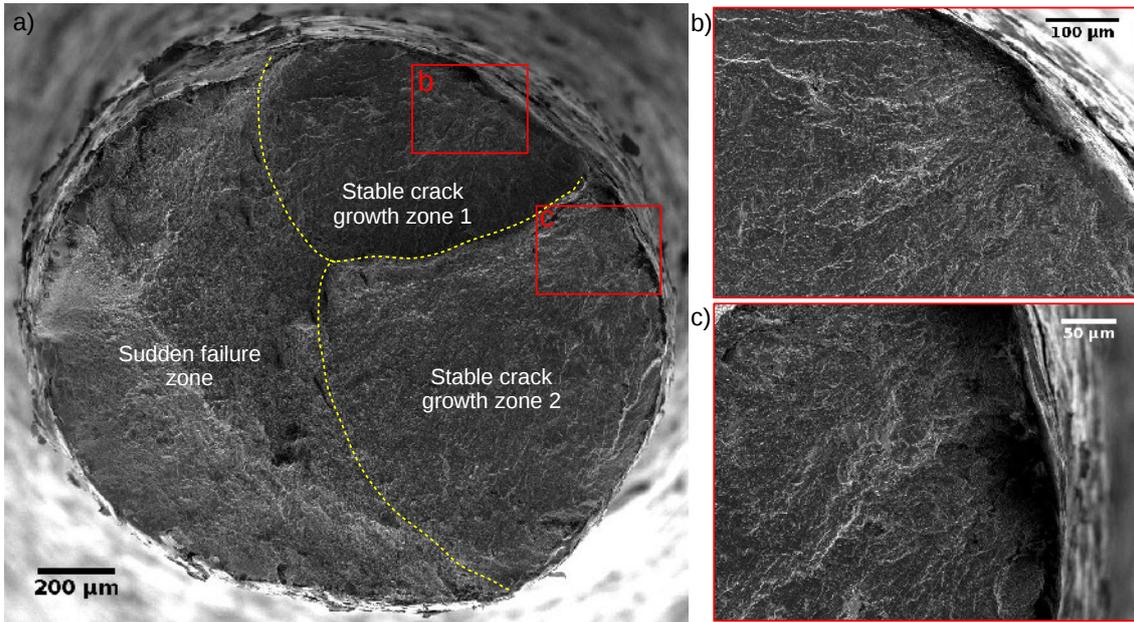
Figure 3.32: SEM-SE micrographs of the fracture surfaces of a 90° EBM fatigue sample HIP treated, chemically etched for 30 minutes and USP treated for 2 hours. (a) Fracture surface showing the stable crack growth and sudden failure zones. (b,c) Higher magnification image showing the two crack initiation sites.

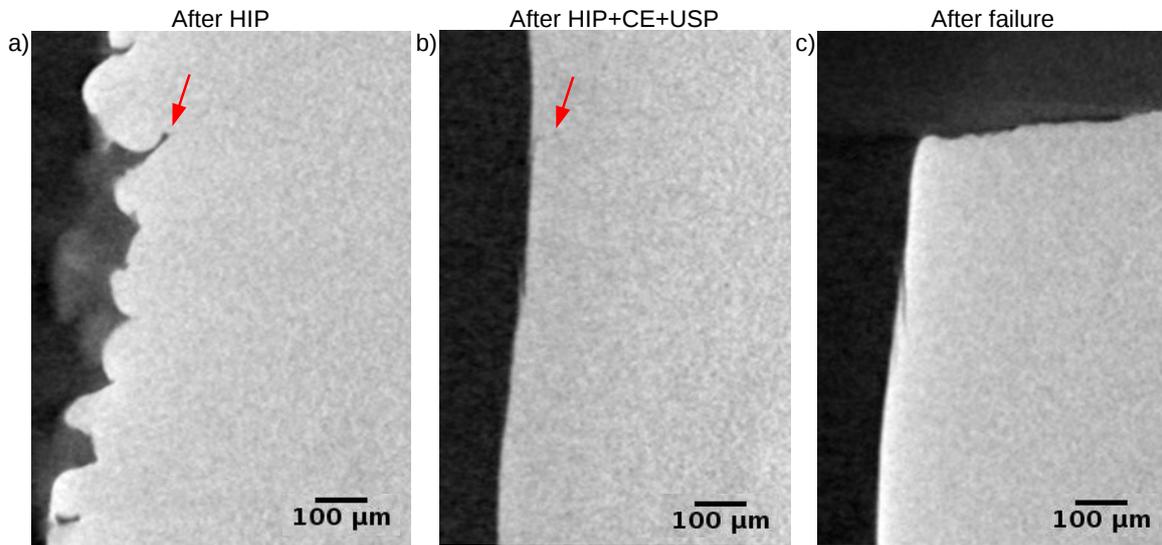
Figure 3.33: Radial slices obtained by X-ray tomography of a 90° EBM fatigue sample HIP treated (a), chemically etched for 30 minutes and USP treated for 2 hours before (b) and after fatigue failure (c). The defect leading to failure is pointed out by a red arrow.

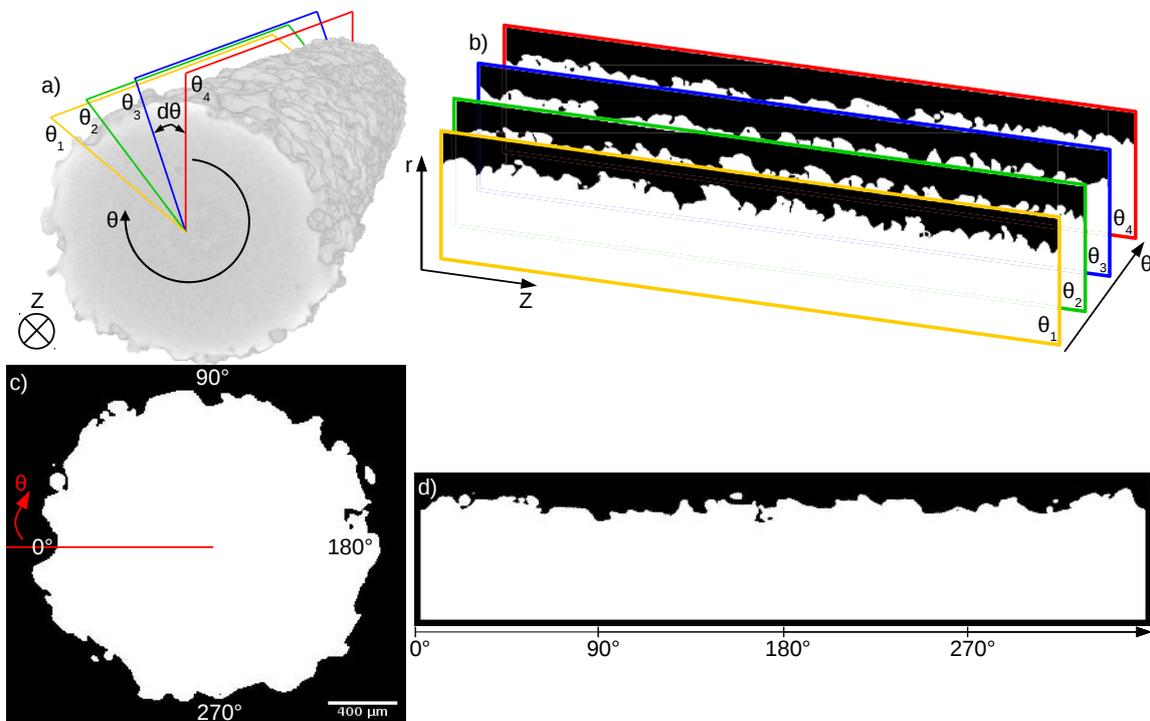
Figure 4.1: (a, b) Schematic illustration of the reslicing process where radial slices are produced from the stack of the sample reconstructed sections. A line starting from the sample central axis and ending at the edge of the tomographic image is rotated around its starting point with a radial step $d\theta$ (in $^\circ$) (a). For every $d\theta$, the software interpolates the image corresponding to the voxels in the (r, z) plane (b). (c, d) Illustration of this “unfolding” process for one binary slice of an as-built sample. (c) Axial slice of the sample. (d) View of the “unfolded” slice after reslicing. The correspondance between the angular position in (c) and the horizontal one in (d) is shown.

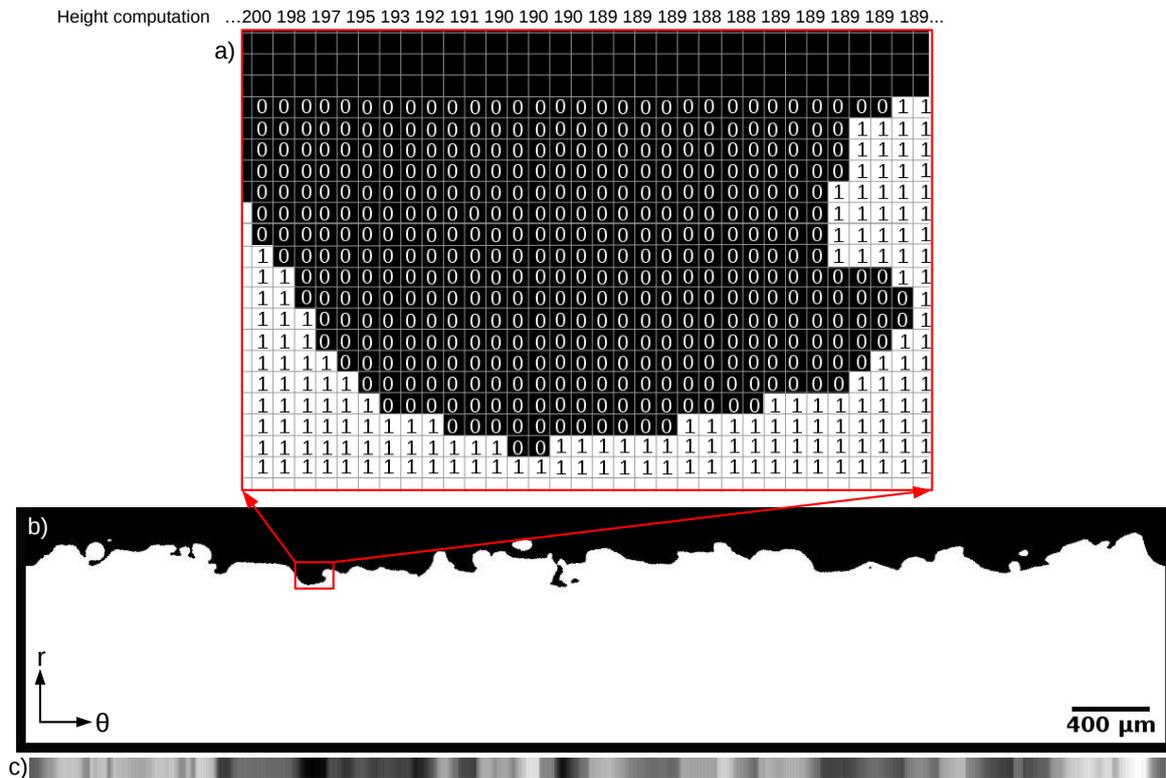
Figure 4.2: Automatic detection of the critical defects: acquisition of the radial distance of all surface points. (a) Illustration of the tomographic images binarization. (b) View of the unfolded slice. (c) Grey scale line obtained from the unfolded slice in (b) (the vertical thickness of the line is arbitrary). The gray colors values (8 bits) correspond to the surface points height.

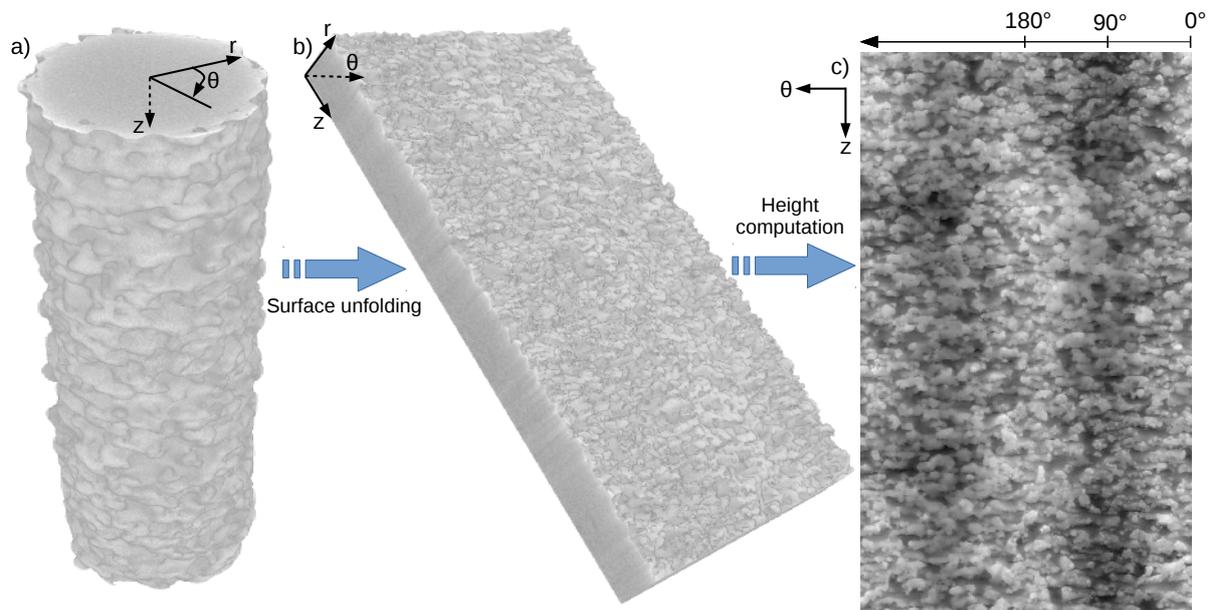
Figure 4.3: Automatic detection of the critical defects: from a 3D volume to a grayscaled surface map. (a) 3D rendering of an a-built sample gauge length. (b) 3D rendering of the same gauge length after unfolding (c) Grey scale surface map. The gray levels correspond to the surface points heights. The angular positions are indicated.

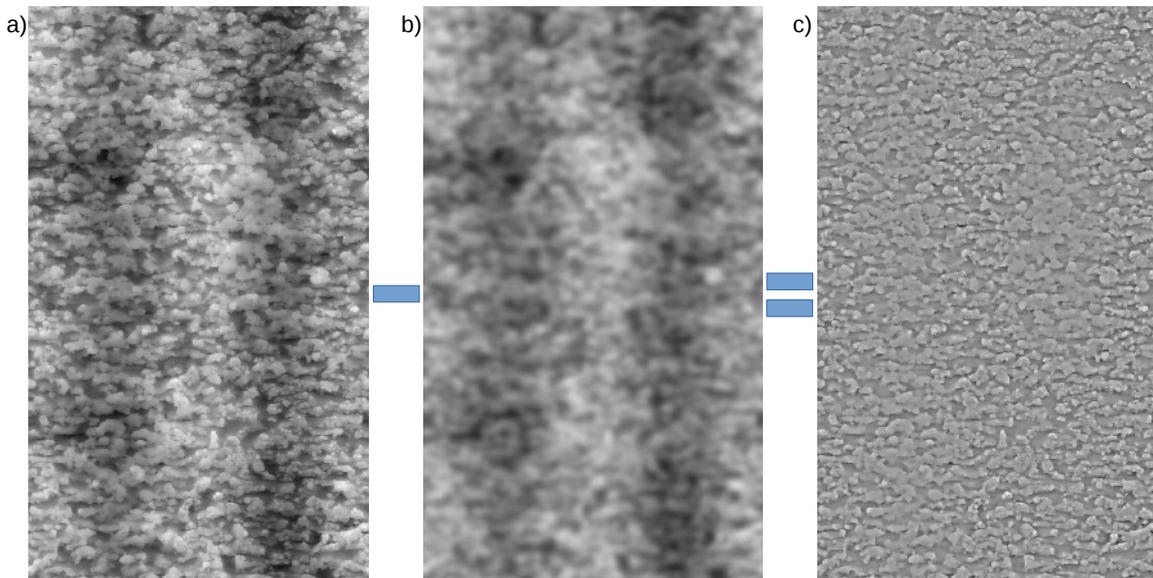
Figure 4.5: Automatic detection of the critical defects: removal of the macroscopic surface height variations. (a) Grey scale surface map. (b) Result of a gaussian blur operation ($r=50 \mu m$) on (a). (c) Surface map showing the local variations of height obtained from the mathematical operation (a)-(b). These maps show the entire sample gauge length (~ 5.8 mm perimeter and 10mm height).

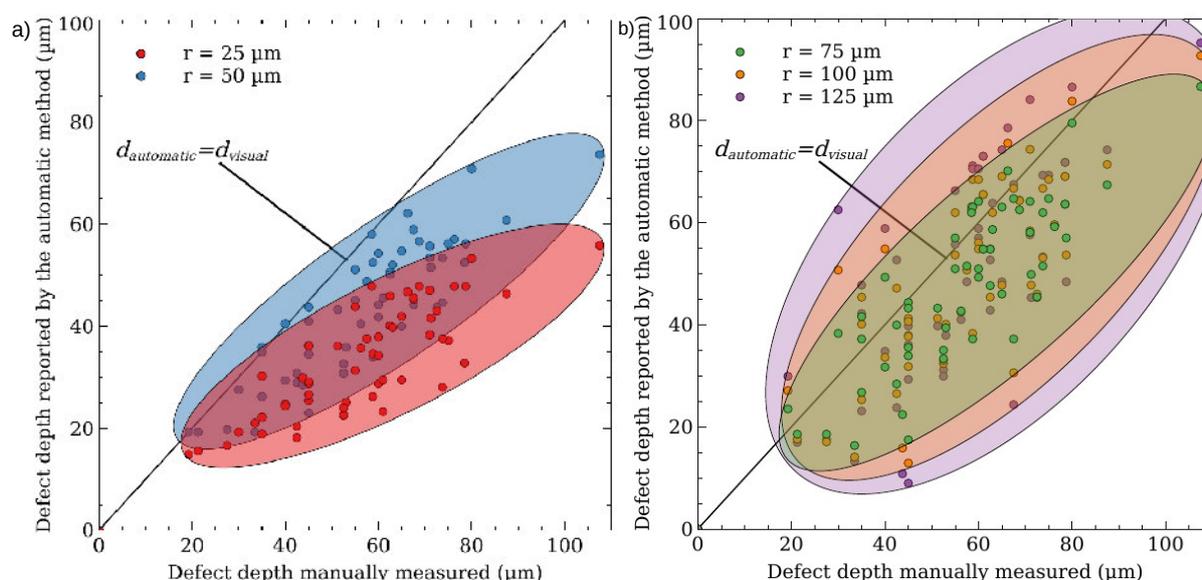
Figure 4.7: Comparison of the depths measurements. Maximum depth values of the detected defects measured by the critical defects identification method for $r = 25$ (red dots) and $50 \mu\text{m}$ (blue dots) (a) and for $r = 75, 100$ and $125 \mu\text{m}$ (b) (green, orange and purple dots respectively) as functions of the maximum depth values measured manually on the tomographic images. For each r value, the envelope containing all the defects distribution is represented by a colored ellipse. The equality between both measurement methods ($d_{\text{automatic}} = d_{\text{visual}}$) is represented by a black line.

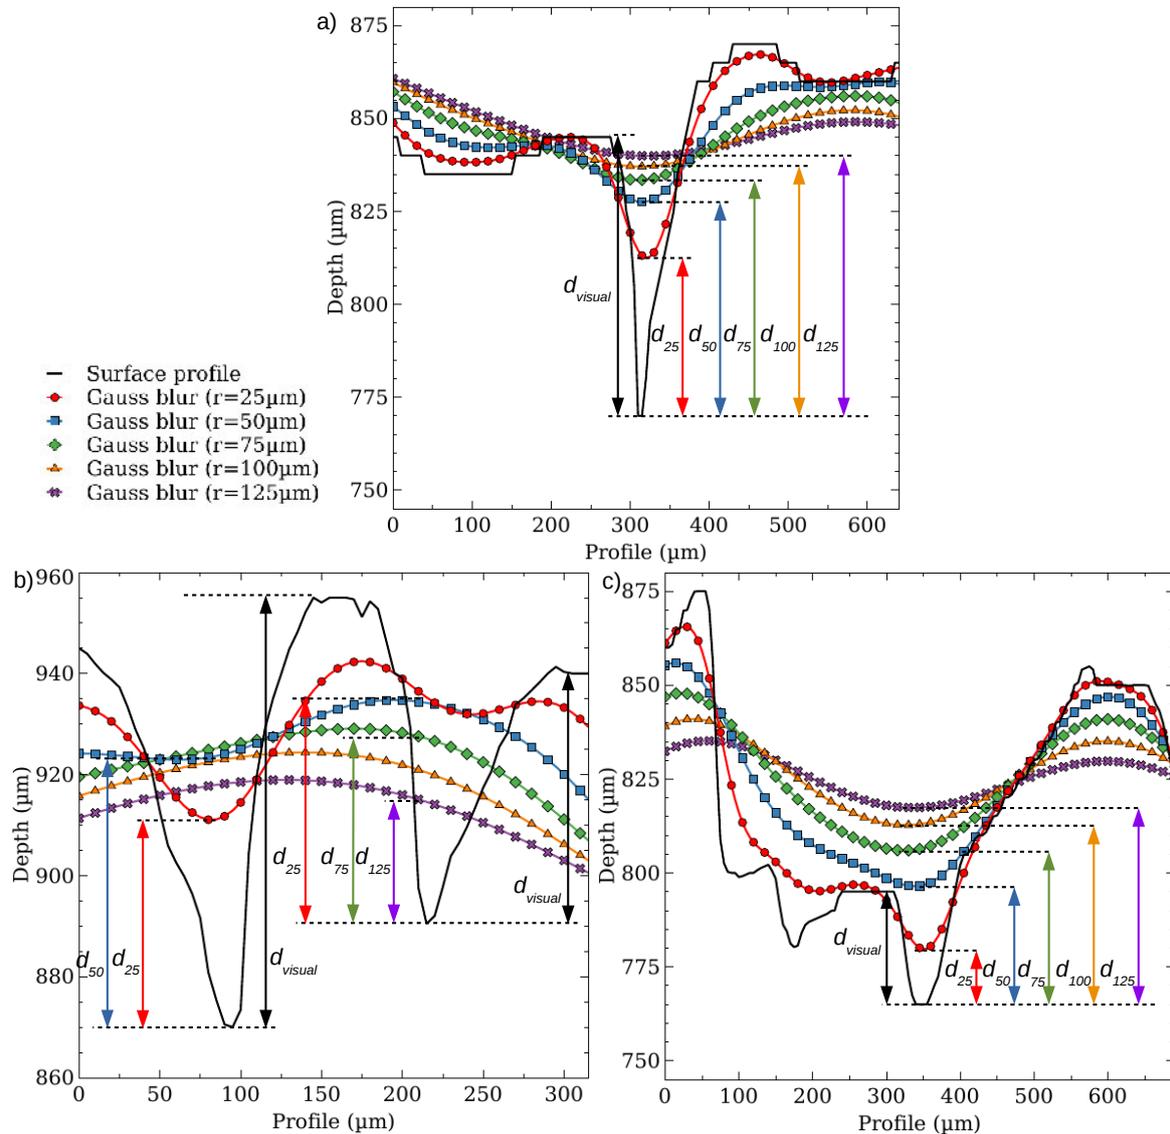
Figure 4.8: Illustration of the gaussian blur impact on the surface profiles of three notch-like defects: an isolated notch-like defect (a), two neighboring notch-like defects (b) and one close to a protrusion. The resulting profiles computed for different r values ($r=25, 50, 75, 100$ and $125 \mu\text{m}$) are represented by lines with respectively red dots, blue squares, green diamonds, orange triangles and purple crosses. The initial surface profiles are shown by black solid lines. Vertical arrows with different colors represent the visual and automatic depth measurements obtained for the different r values.

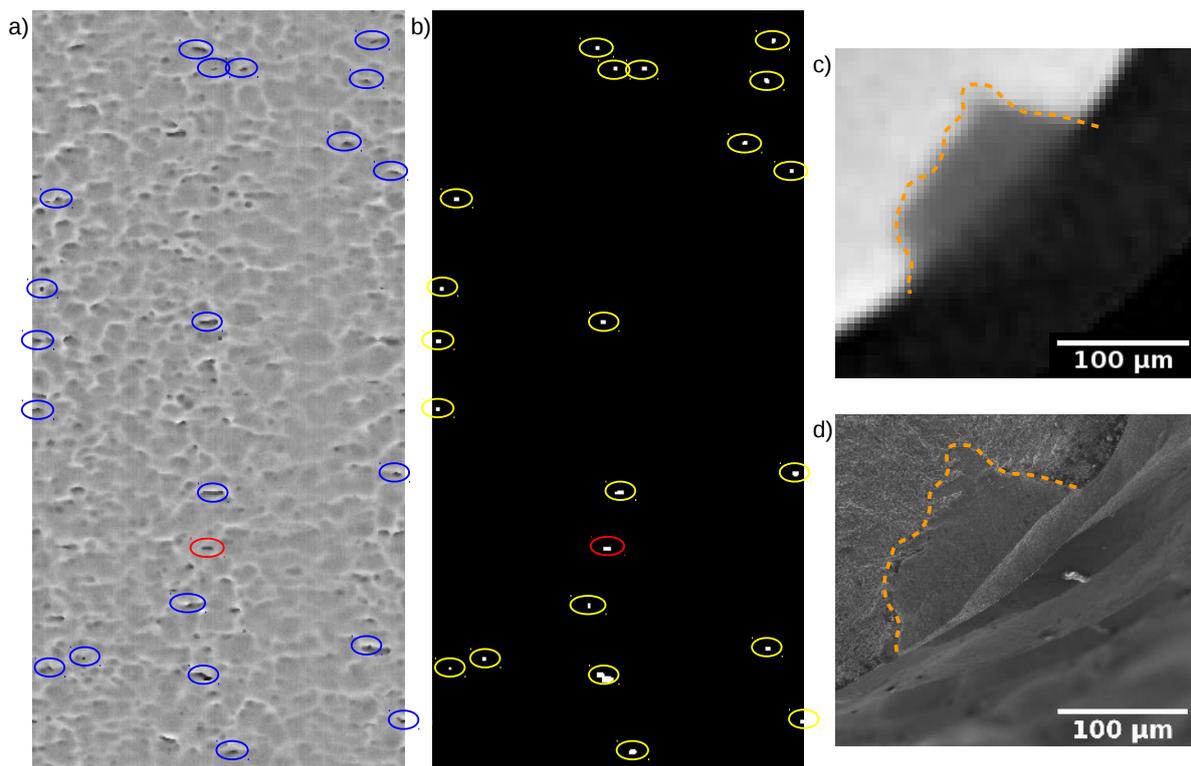
Figure 4.9: Detection of the defect responsible for the sample fatigue failure. Final surface map obtained for $r = 50 \mu\text{m}$ before (a) and after depth thresholding (b) ($TS = 50 \mu\text{m}$). The remaining defects after thresholding are circled in blue in (a) and yellow in (b). The defect responsible for the failure is circled in red. Dilatation operations have applied to (b) so that the detected defects could be visualized more clearly. Axial tomographic image (c) and SEM fracture surface micrograph (d) of the defect responsible for the failure.

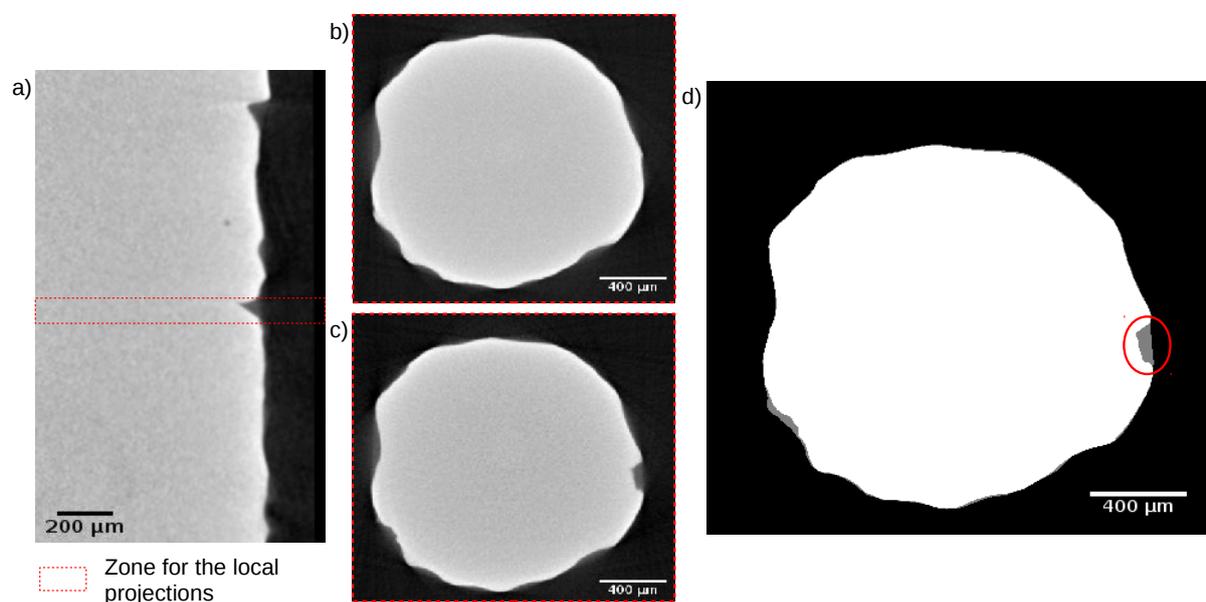
Figure 4.10: Illustration of the process used to measure the projected surface of the defect which has led to failure based on tomographic images. (a) Radial view of the defect which shows by dashed lines the limited zone used for the local projections. Maximum (b) and minimum (c) axial projection around the defect. (d) Average computation of both projections after their binarization. The projected area of the defect (circled in red) appears in gray.
